A Philips 638A of 1934 by Gary Tempest

This is a French version of our 472A (Trader Sheet 680) but with more chic to the cabinet having nice curves rather than just a couple of straight bars across the speaker grill.

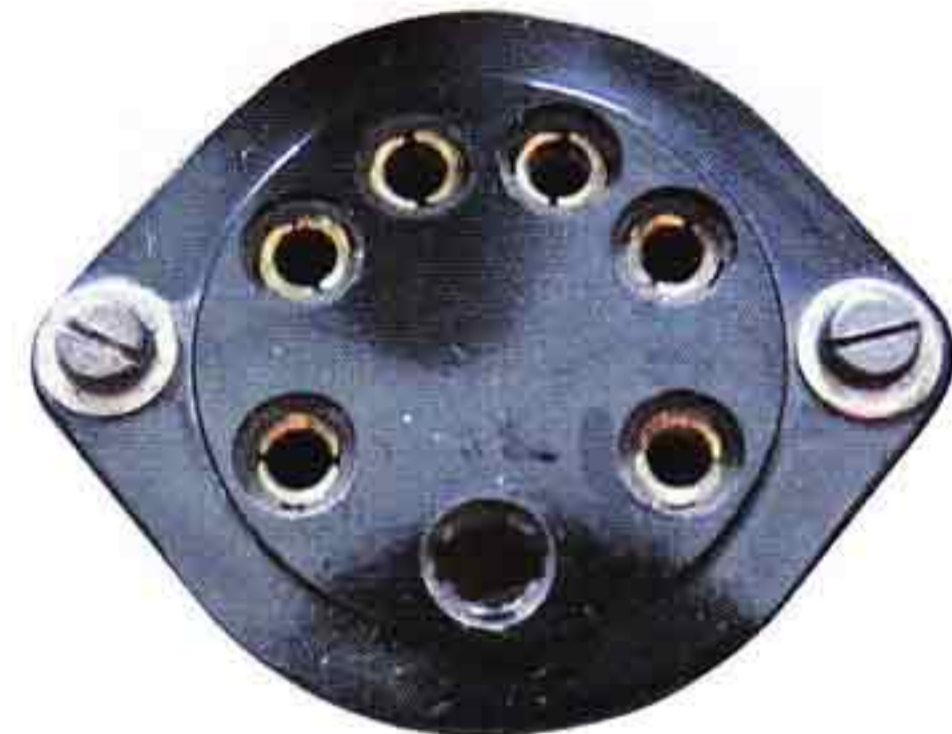
Europe 6 pin base

should have been an E463. The previous repairer had fitted an AL4, which has a Ct8 side contact base, by using an adapter made from a socket and the original valve base. What he hadn't done was to change the bias from the 6V it needed, from the 22V used for the original type. The obvious replacement was a Pen4VA, as per the 472A, and I had a good one of these. It was here that I thought I was losing it, as the B7 base wouldn't fit the socket. It was similar but the spacing was definitely different even though the AVO valve data book said the E463 also had a B7 base. Thank goodness for the Internet and a search on there confirmed that the base was a Europe 6 pin, B6 but it does have one unused hole (see picture) so that at first glance and even a second look made me think that it was B7. It was fairly easy to get around as I have mastered how to change bases on valves. Off with the B7 base, on the Pen4VA, and on with the B6 base salvaged from the adapter.

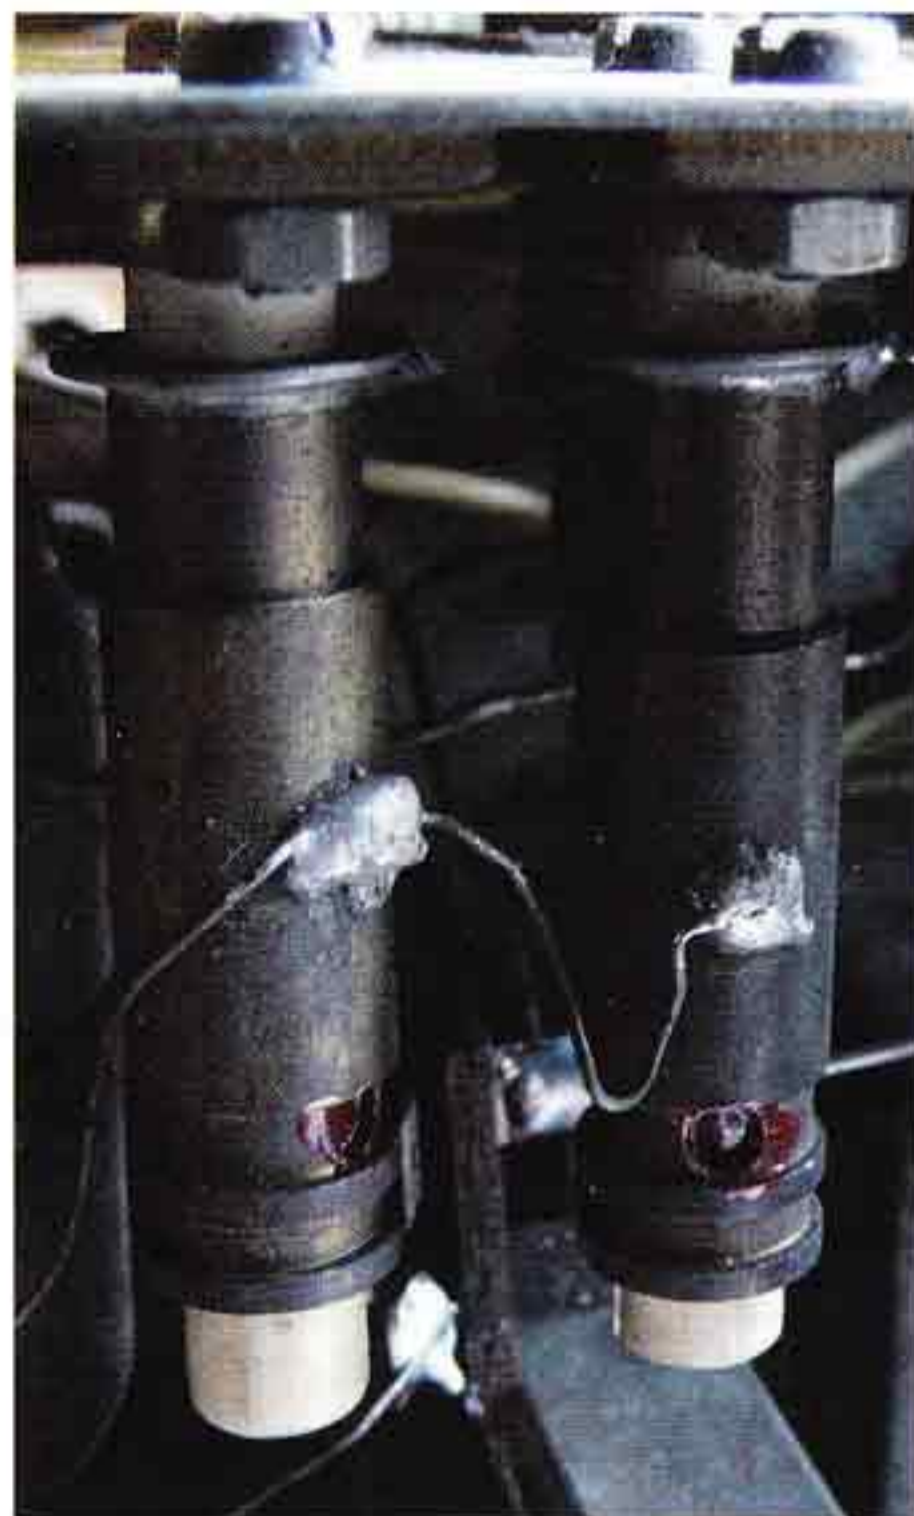
Note: I did remove a trimmer on a Philips 834C set (see picture) and they are beautifully engineered. The outer brass casing slides along the ceramic post enclosing, as it does so, the fixed tube at the bottom. The air gap is tiny.

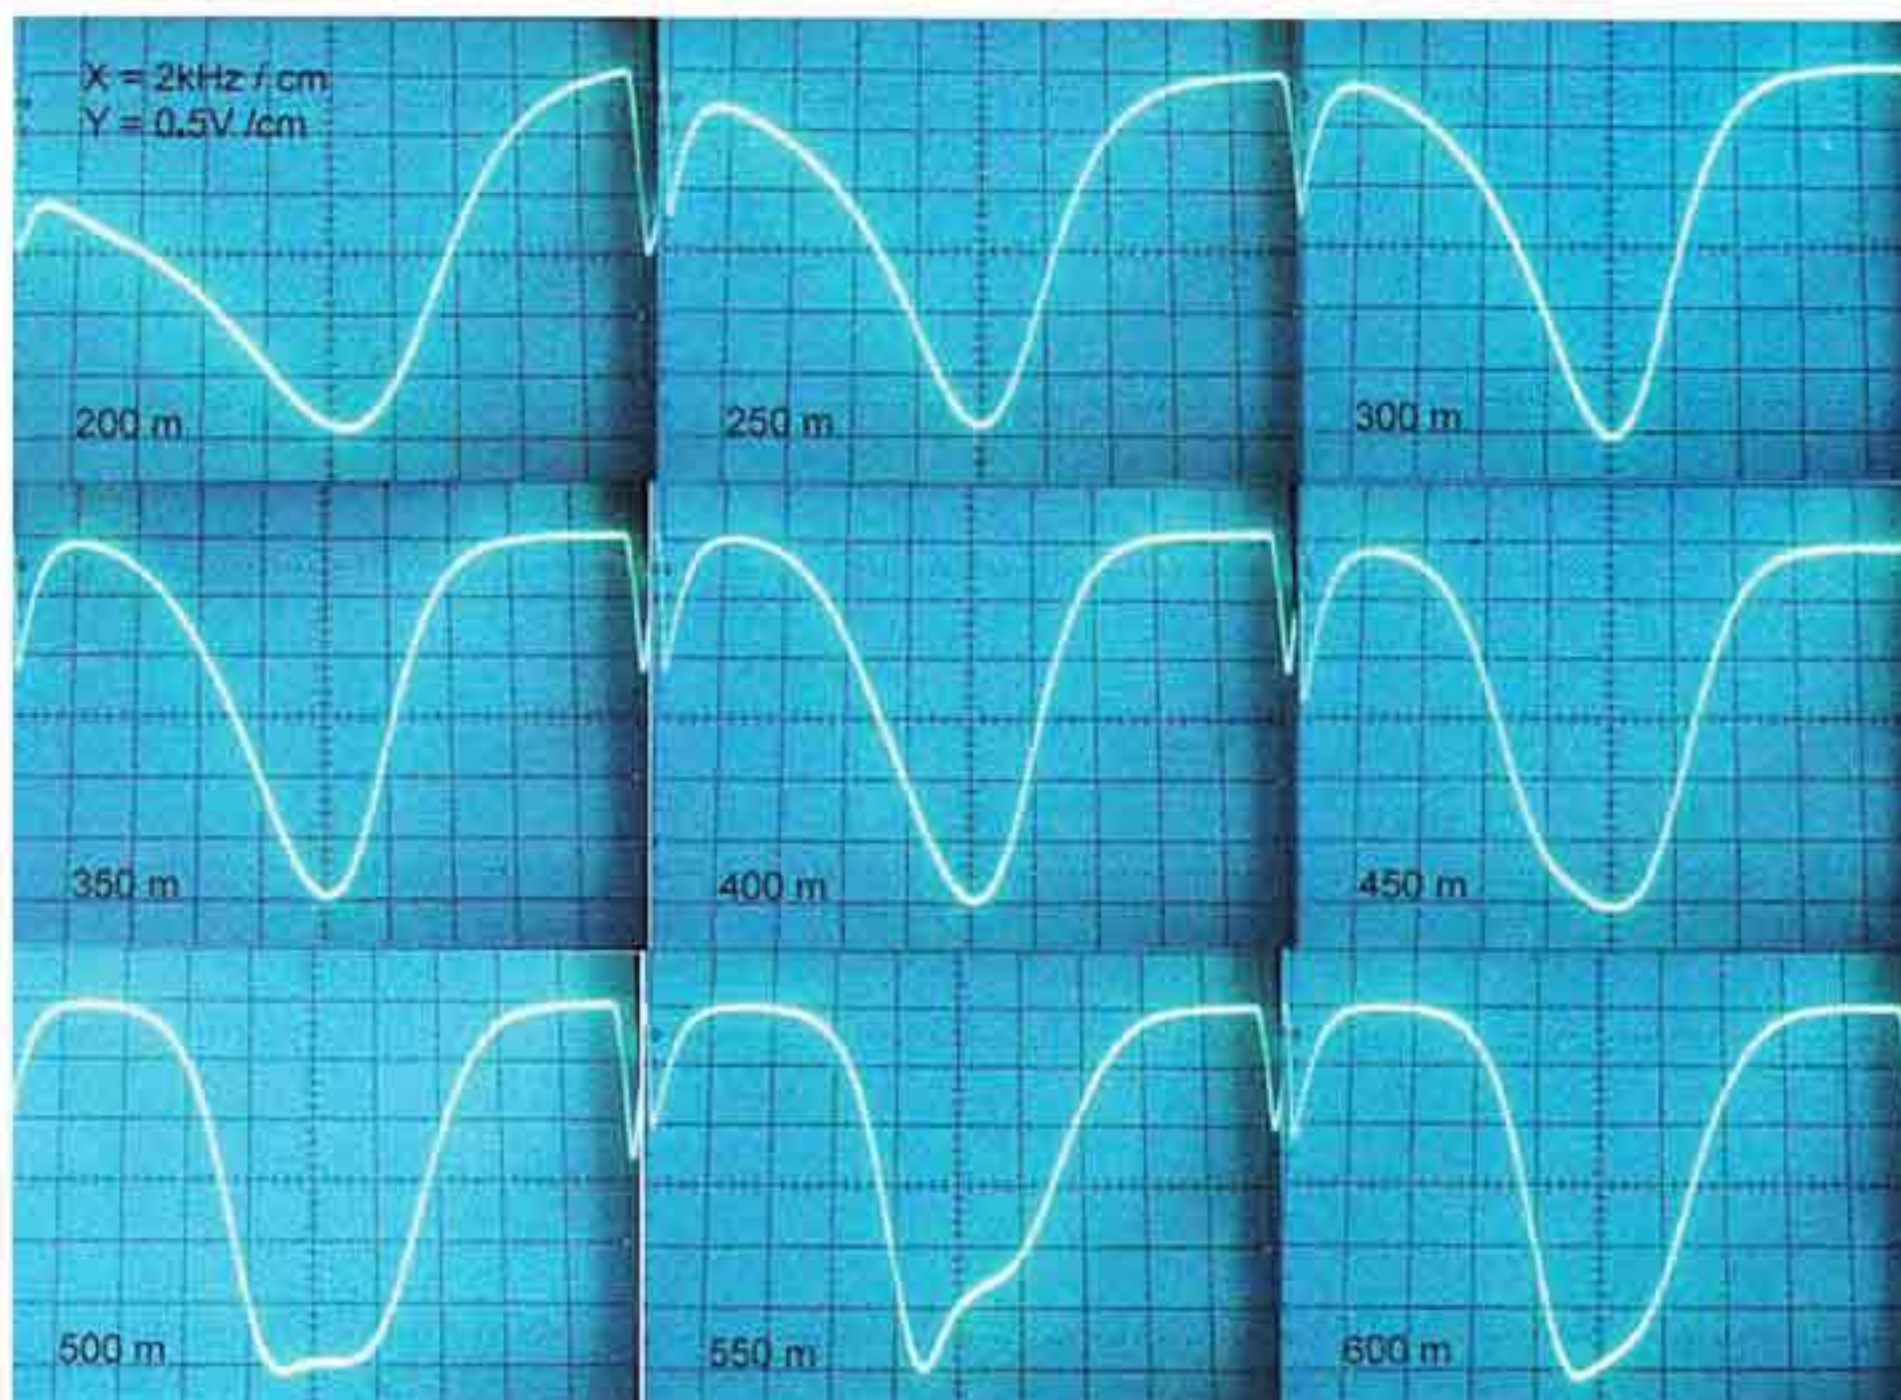
Philips 638A MW Bandwidths

Input to skt. via dummy aerial.

Measured at junction R19 / R20
820pF to ground

There is an impressive pass band characteristic right across the MW band. With my Philips 834C radio, which doesn't have it, the shape departs from 450m to 600m into two peaks, with a valley, even after optimising with the trimmers. This is of course what extra filters smooth out.

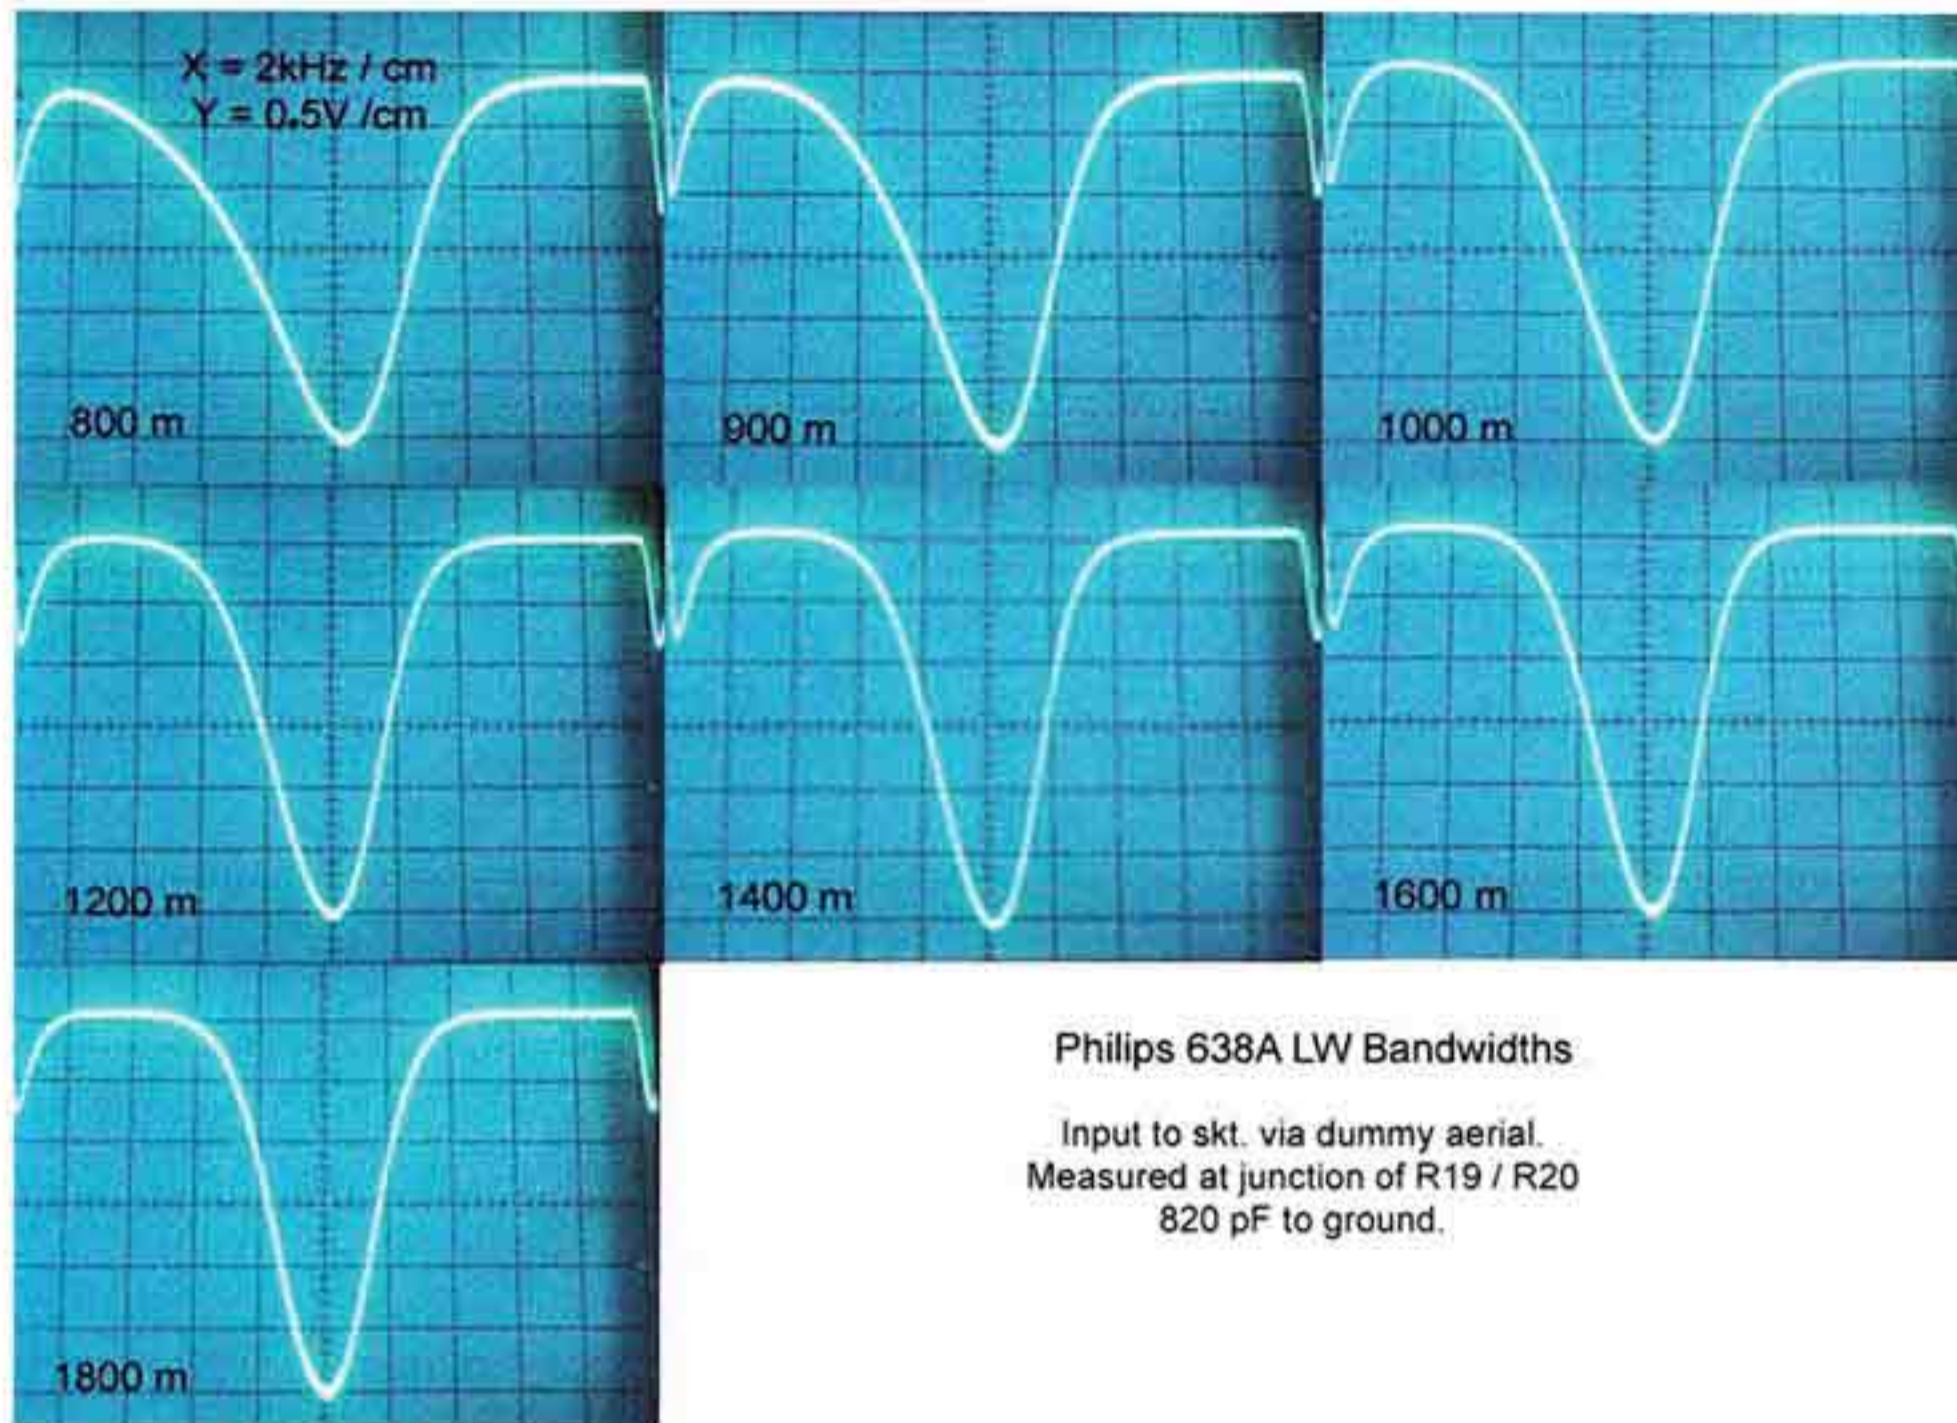
Philips 638A LW Bandwidths

On LW there is little performance difference, between the radios, which I put down to the lower frequencies making good tuneable filtering easier to achieve. I confirmed these bandwidths by measuring the carrier frequencies of a modulated signal generator, using a frequency counter and oscilloscope. This was monitoring the detected audio for the half height point (6dB). Results were slightly lower (say 10-20%) to the bandwidths shown on the LW Wobbulator picture.

So LW has not much more than analogue telephone bandwidth (300 - 3400 Hz). This may have been fine at the time with sensitivity and selectivity being of prime importance and a mellow sound being normal.

Input to skt. via dummy aerial.
Measured at junction of R19 / R20
820 pF to ground.
