Ekco A22 rebuild

by Robert Darwent (robert.g0uhf@gmail.com)

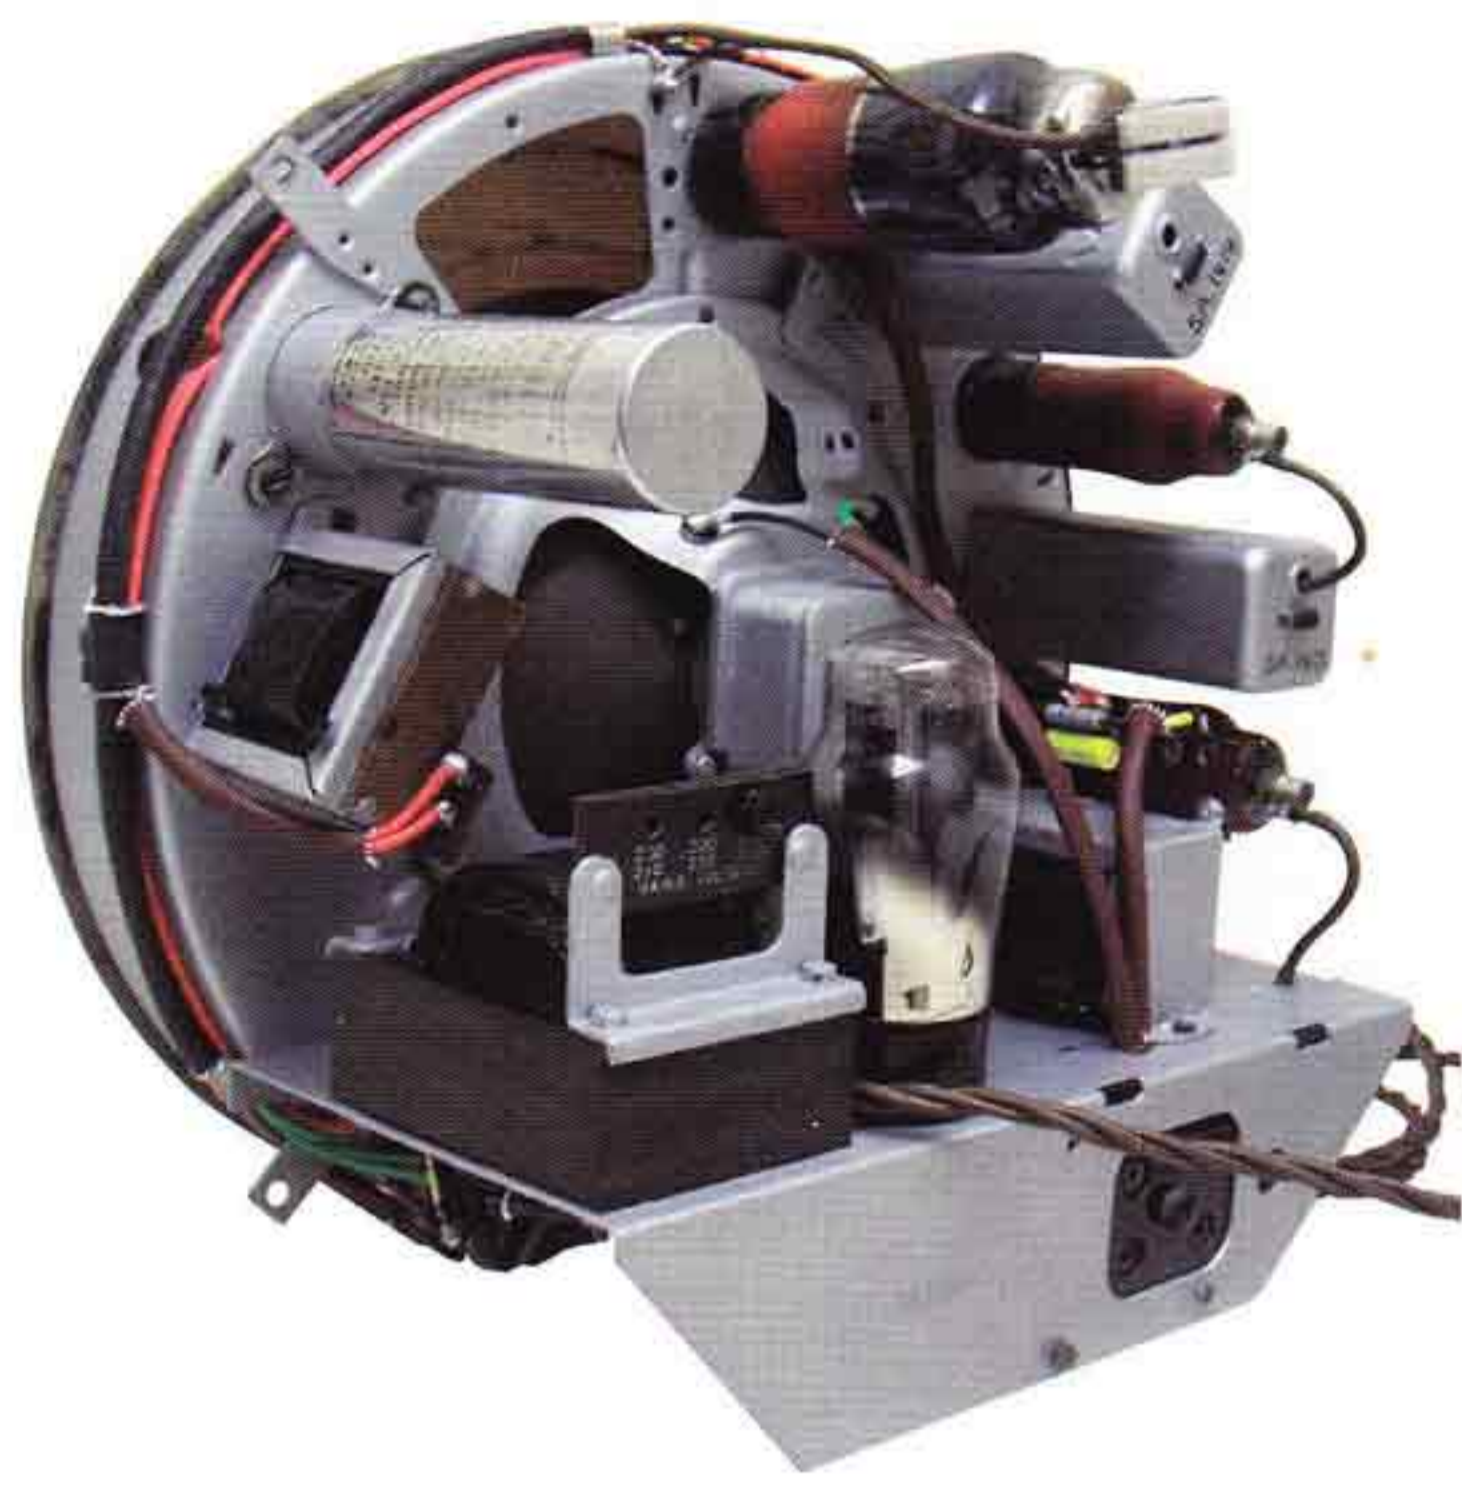
daubed with black paint that looked more like hardened black treacle in places. I removed the chassis and was again shocked by what I saw. The state of the wiring was terrible! A few wires had obviously been renewed by modern red and orange, but most was original, hard, brittle and flaking, showing exposed wire. If I'd have known this beforehand I would have never applied power. So much for the comprehensive overhaul! I was really surprised the set worked as well as it did in this condition.

Further investigation showed the 'overhaul' to have included replacement of all but one of the wax capacitors with

apparently whatever type and value was to hand at the time. Some of the resistors had been changed as well, again seemingly with whatever was to hand. But the 'new' wiring really was something! Most obvious a crude screening braid made from what I assume was the outer layer of a piece of co-axial cable. I'll leave the 'before' and 'after' images to illustrate in detail and speak for themselves here.

Well there was nothing for it really but a complete restoration. My thoughts were that since I had already been deprived of the preferred option of carrying out a sympathetic restoration by the previous owner, I would instead restore

the set to be as reliable as possible. I needed to get rid of that horrible black paint and I could only do that properly by completely stripping the chassis. Obviously all the wiring needed replacing too, it was just downright dangerous.

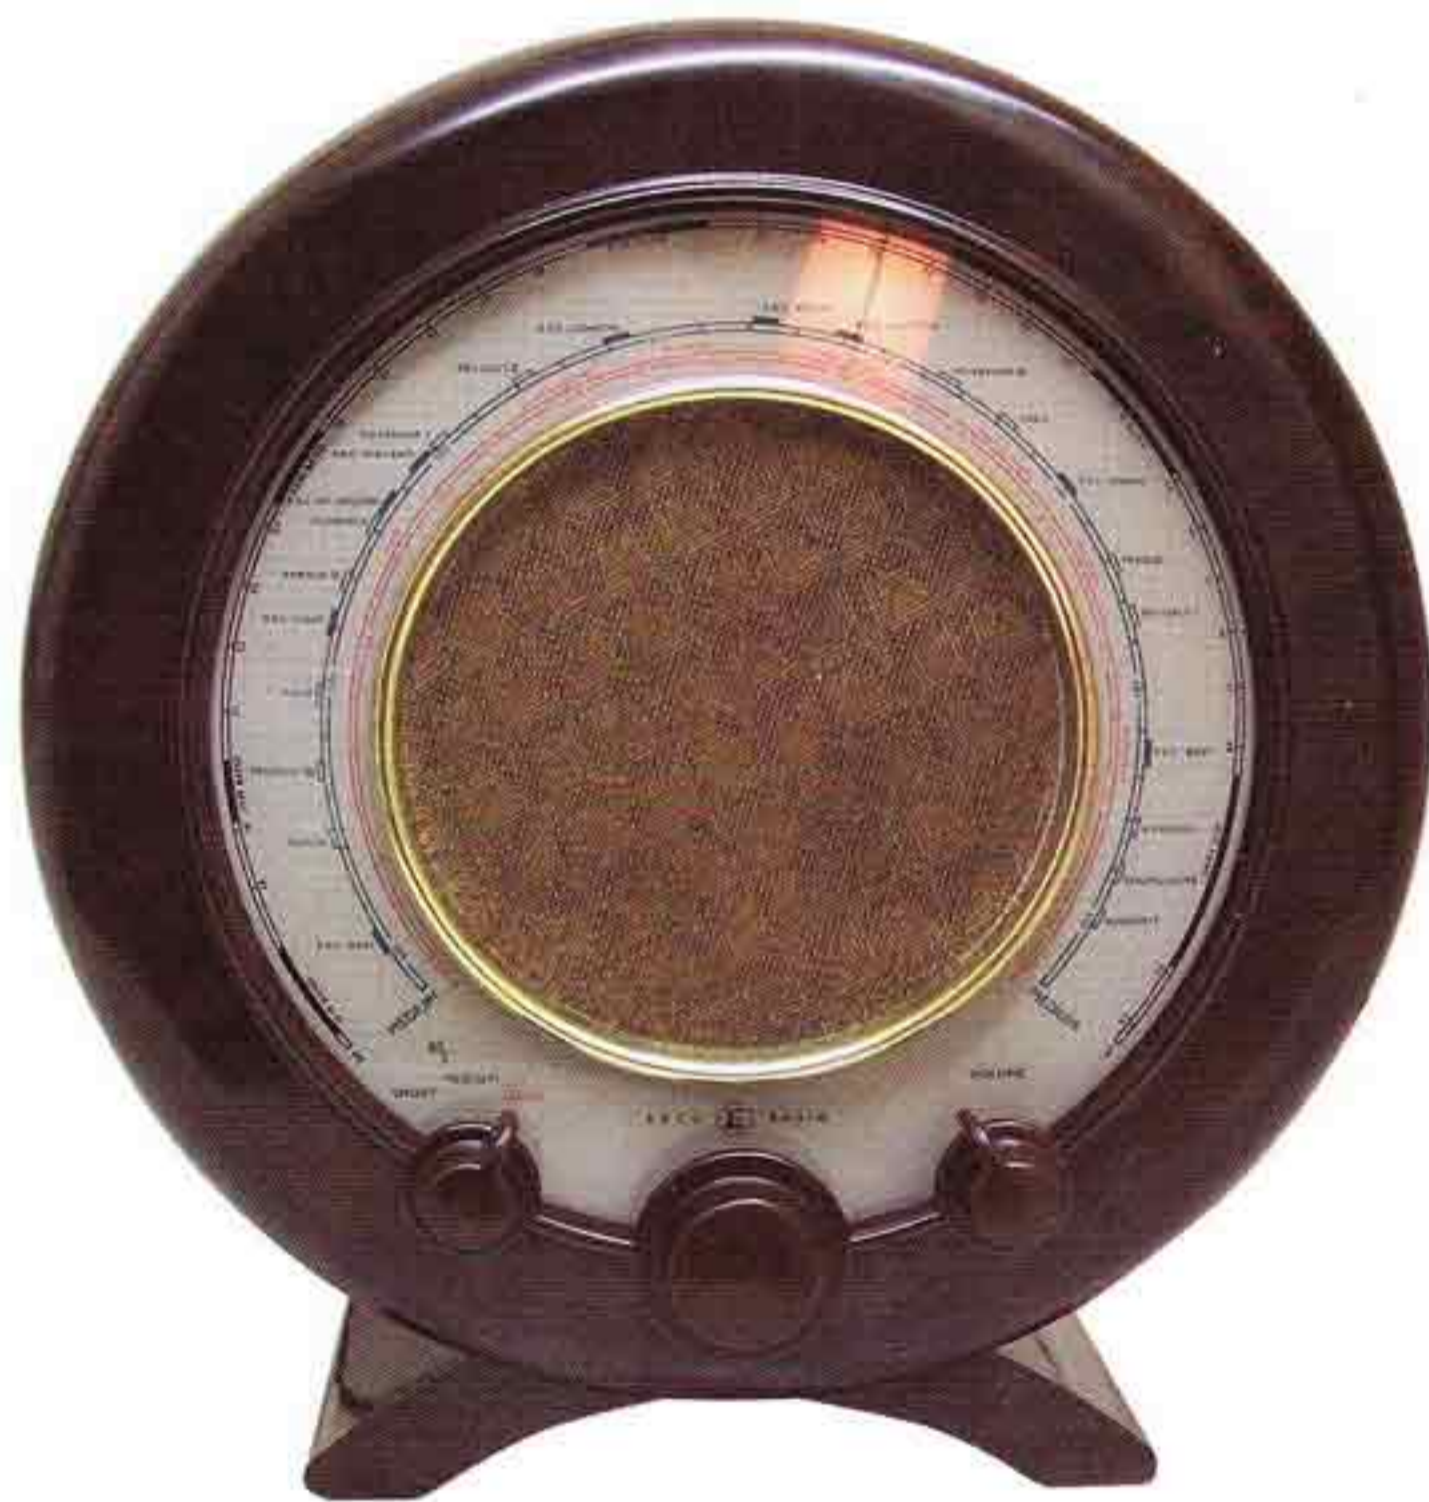
I spent quite a while carefully dismantling and stripping down the metalwork. Once I had a bare chassis, I removed the black paint quite easily thankfully with a jelly-type paint stripper applied to small areas at a time. The chassis was quite discoloured underneath due to light rusting in places and was the reason for the coat of black paint I assume. I repainted with silver Smoothrite for most of the

metalwork, with black Smoothrite on the underside, as per the original finish.

As for replacement capacitors, I would have liked to have restuffed the original wax components with modern versions if they were in a good enough condition to do so. But as they had already been removed and were no longer an option, I replaced with 630V rated yellow polypropylene types instead. I decided I may as well change all the resistors as well, since several needed changing anyway or had been caught with that horrid paint. I replaced with modern 2W metal film types because of their similar dimensions to the originals. The two can-type electrolytics were both

restuffed with modern components and refitted at this time also. At least the set now had a consistent type of capacitor and resistor fitted of the correct values and in my opinion looked much better for it even if a little more of the remaining originality had been lost by doing so.
