# The Philips 372B *Super Inductance* By R.J.Grant

A battery set as suggested by the 'B' in the model number, from the Philips "Super inductance" range. I purchased this set from a boot fair, when the back was removed it was found to still have both of its batteries, a Drydex combination HT with grid Bias battery, and a glass accumulator. Unfortunately on discovering the batteries inside I failed to hide my enthusiasm, this didn't leave much manoeuvring room when it came to reducing the price. The battery is a real bonus as the batteries in these sets are often missing and an original to restore or as a pattern to reproduce for another set which really makes it a double-find.

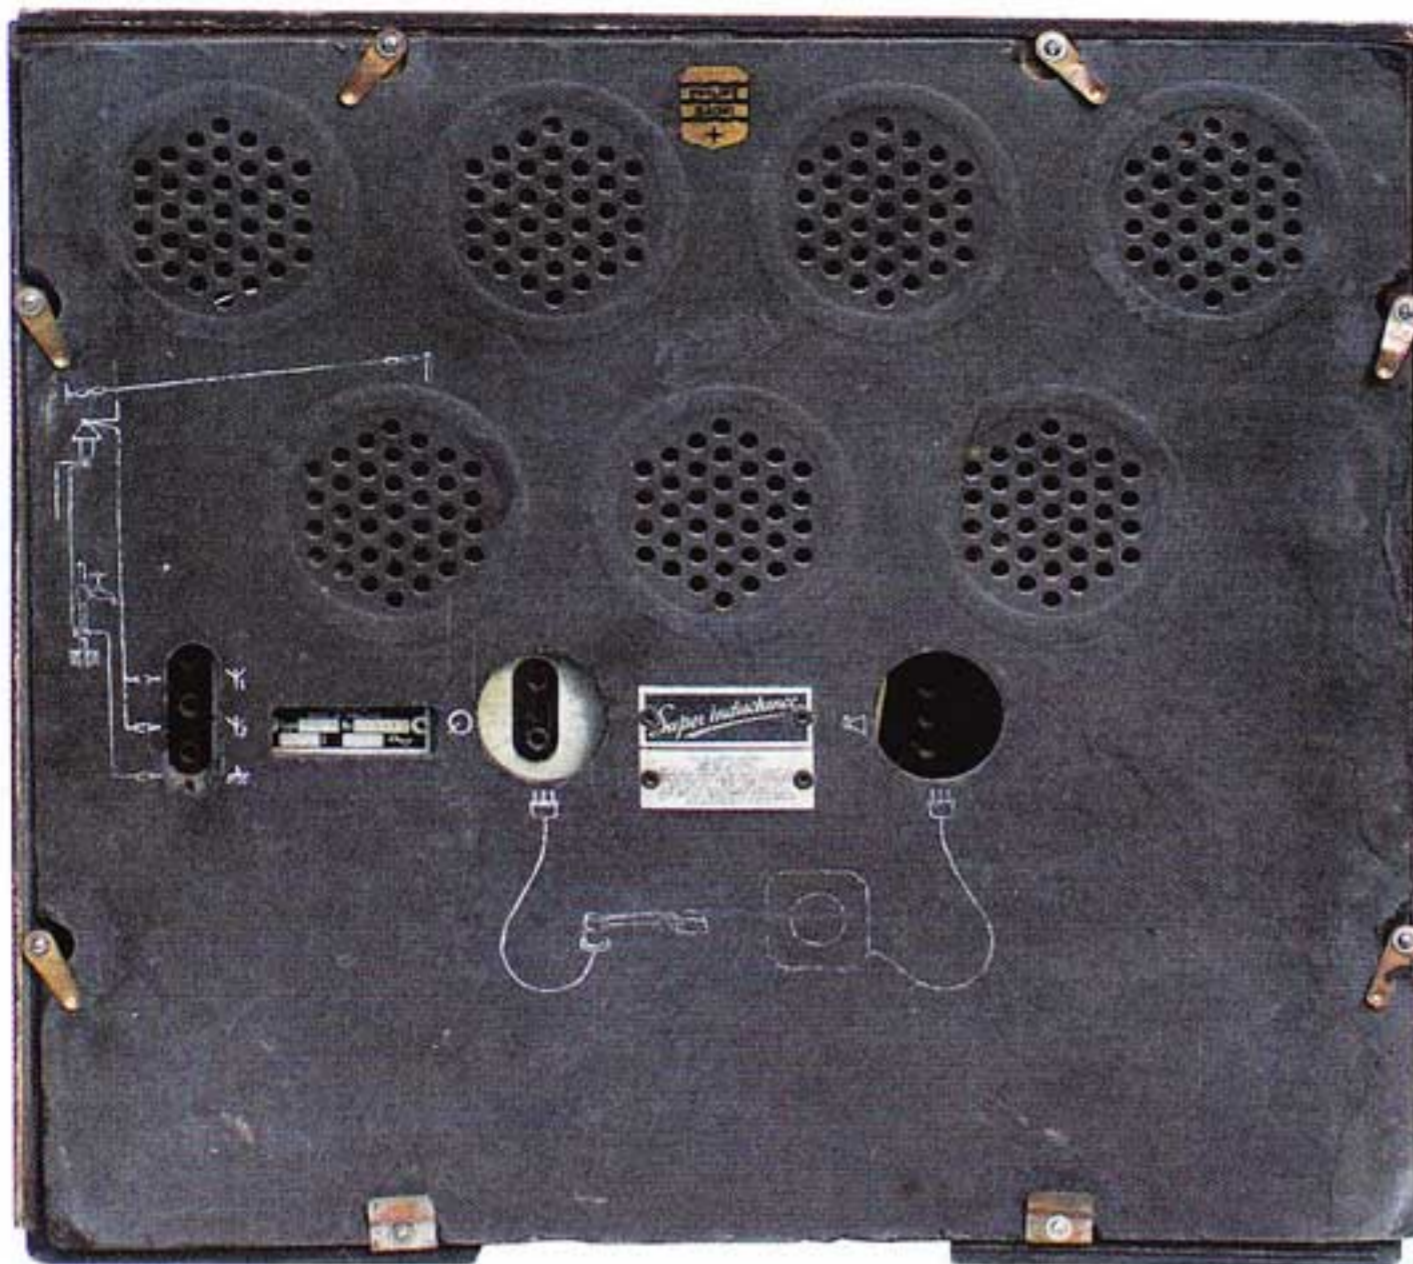
The back showing aerial details

Running the set on its internal plate aerial in the top of the cabinet made the set very deaf but there is a diagram of the aerial requirements and how to use the water main as an earth on the back of the set, so I expect the plate aerial is for local stations only.

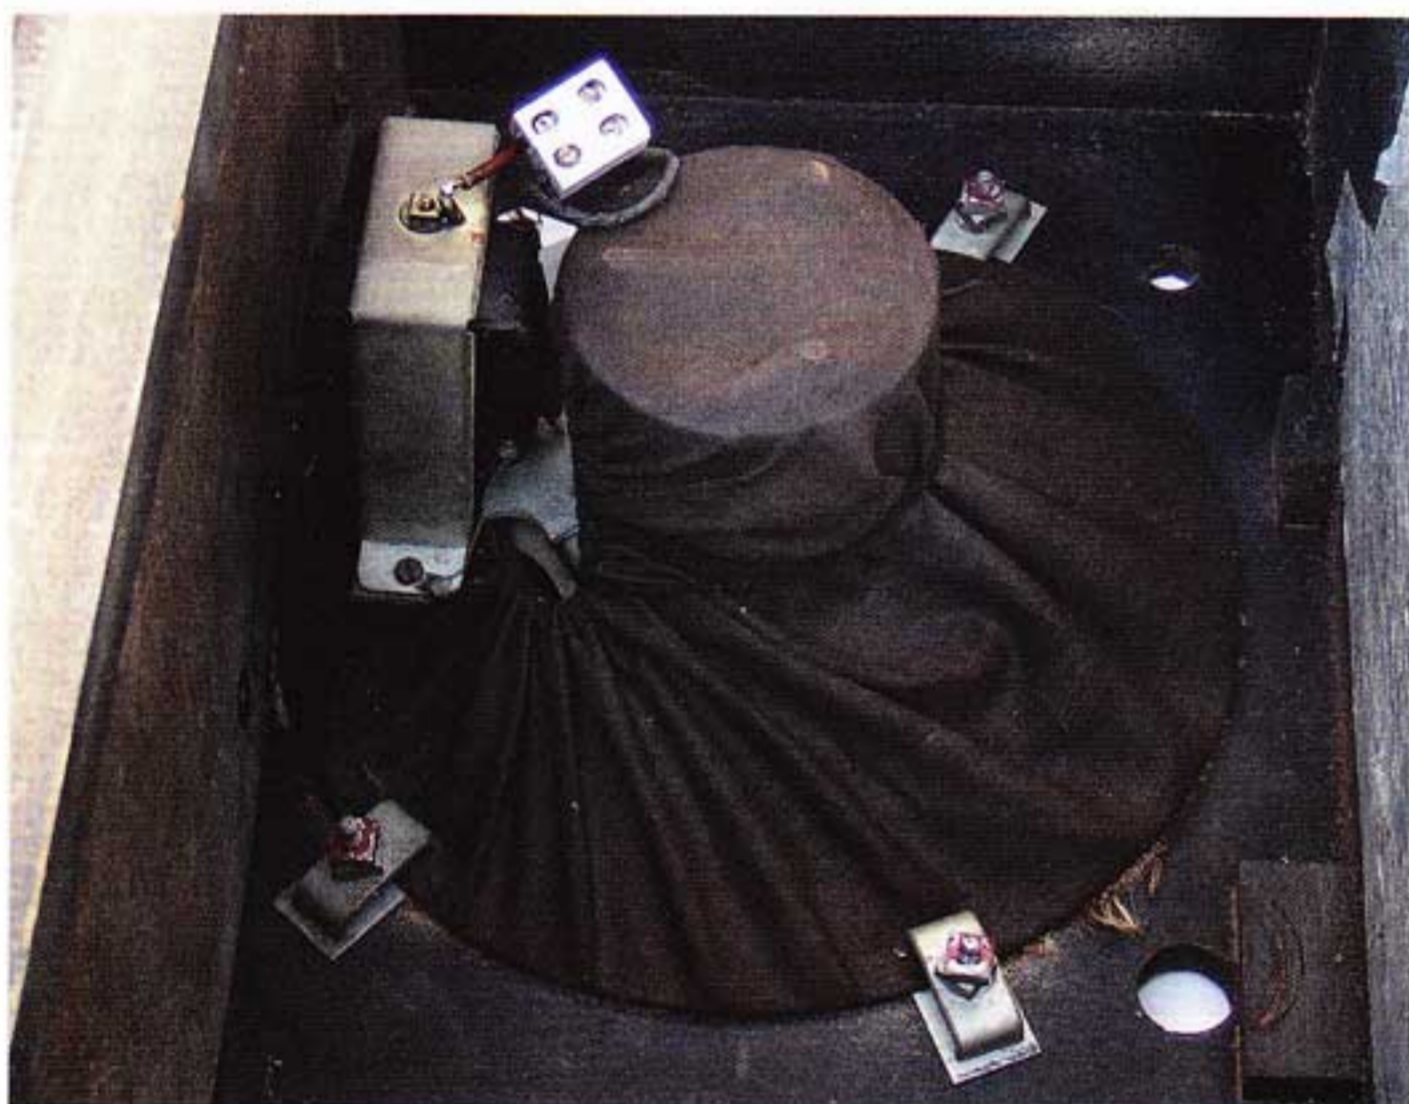
The speaker re-installed

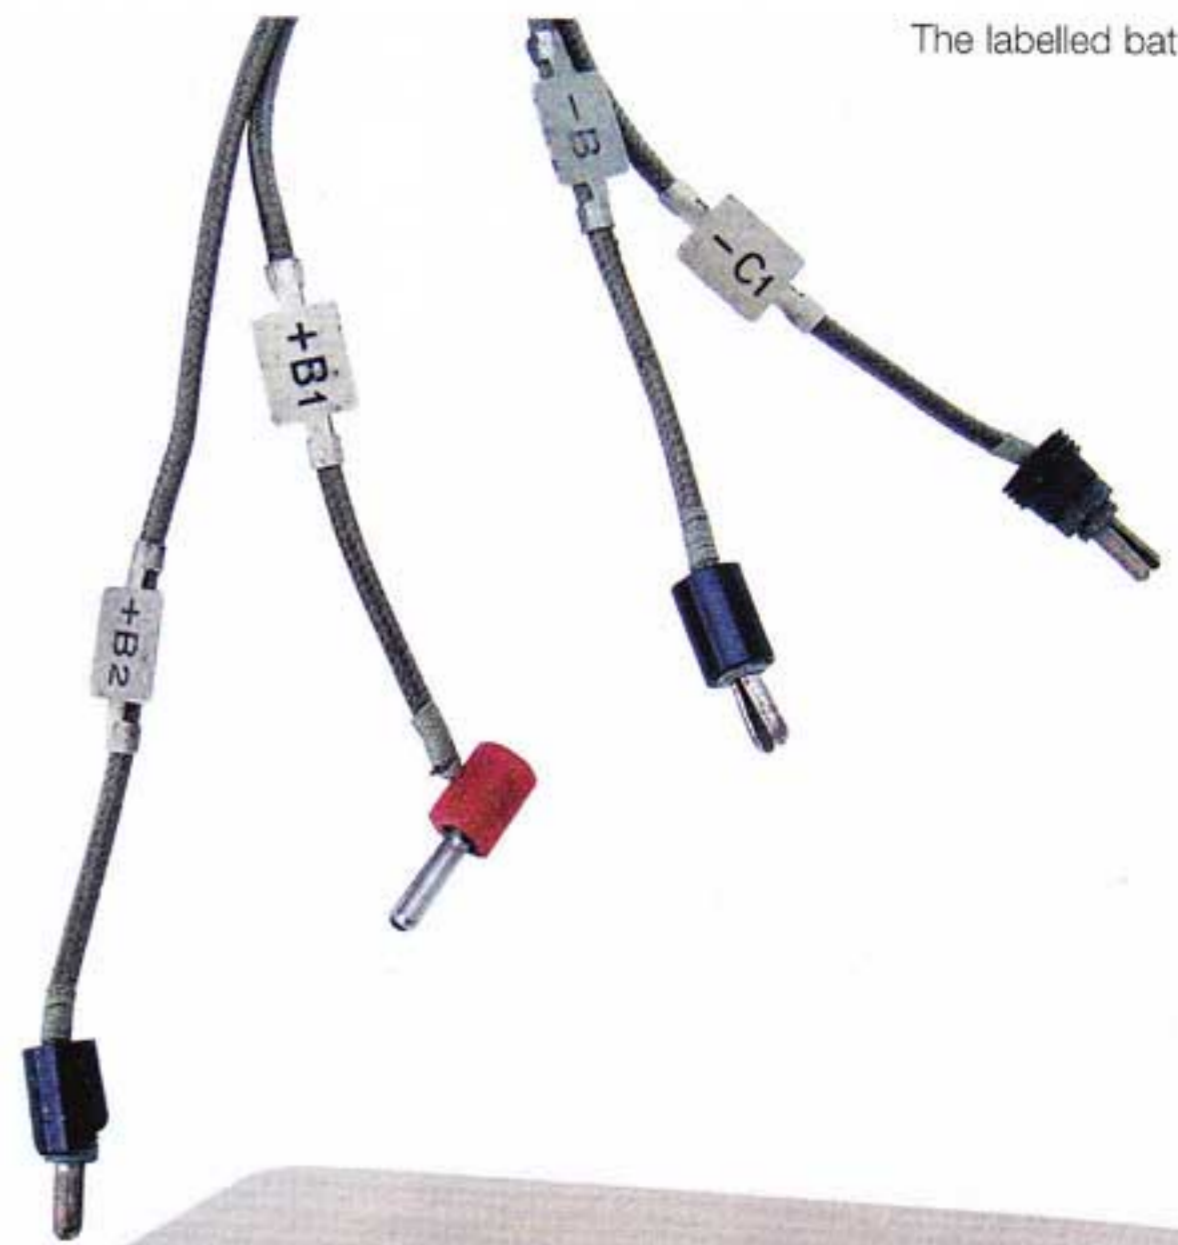
The labelled battery leads

There are a few nice features about this set other than the fine woodwork cabinet, there is a terminal panel for the battery leads making it very easy for the repair man to replace them when they get short, and they always do on battery sets as the wander plugs keep falling off and need refitting. All of the coils are sealed inside their screening cans as are the paper capacitors, protecting them from the elements, perhaps that's why it only needed a valve to repair it.

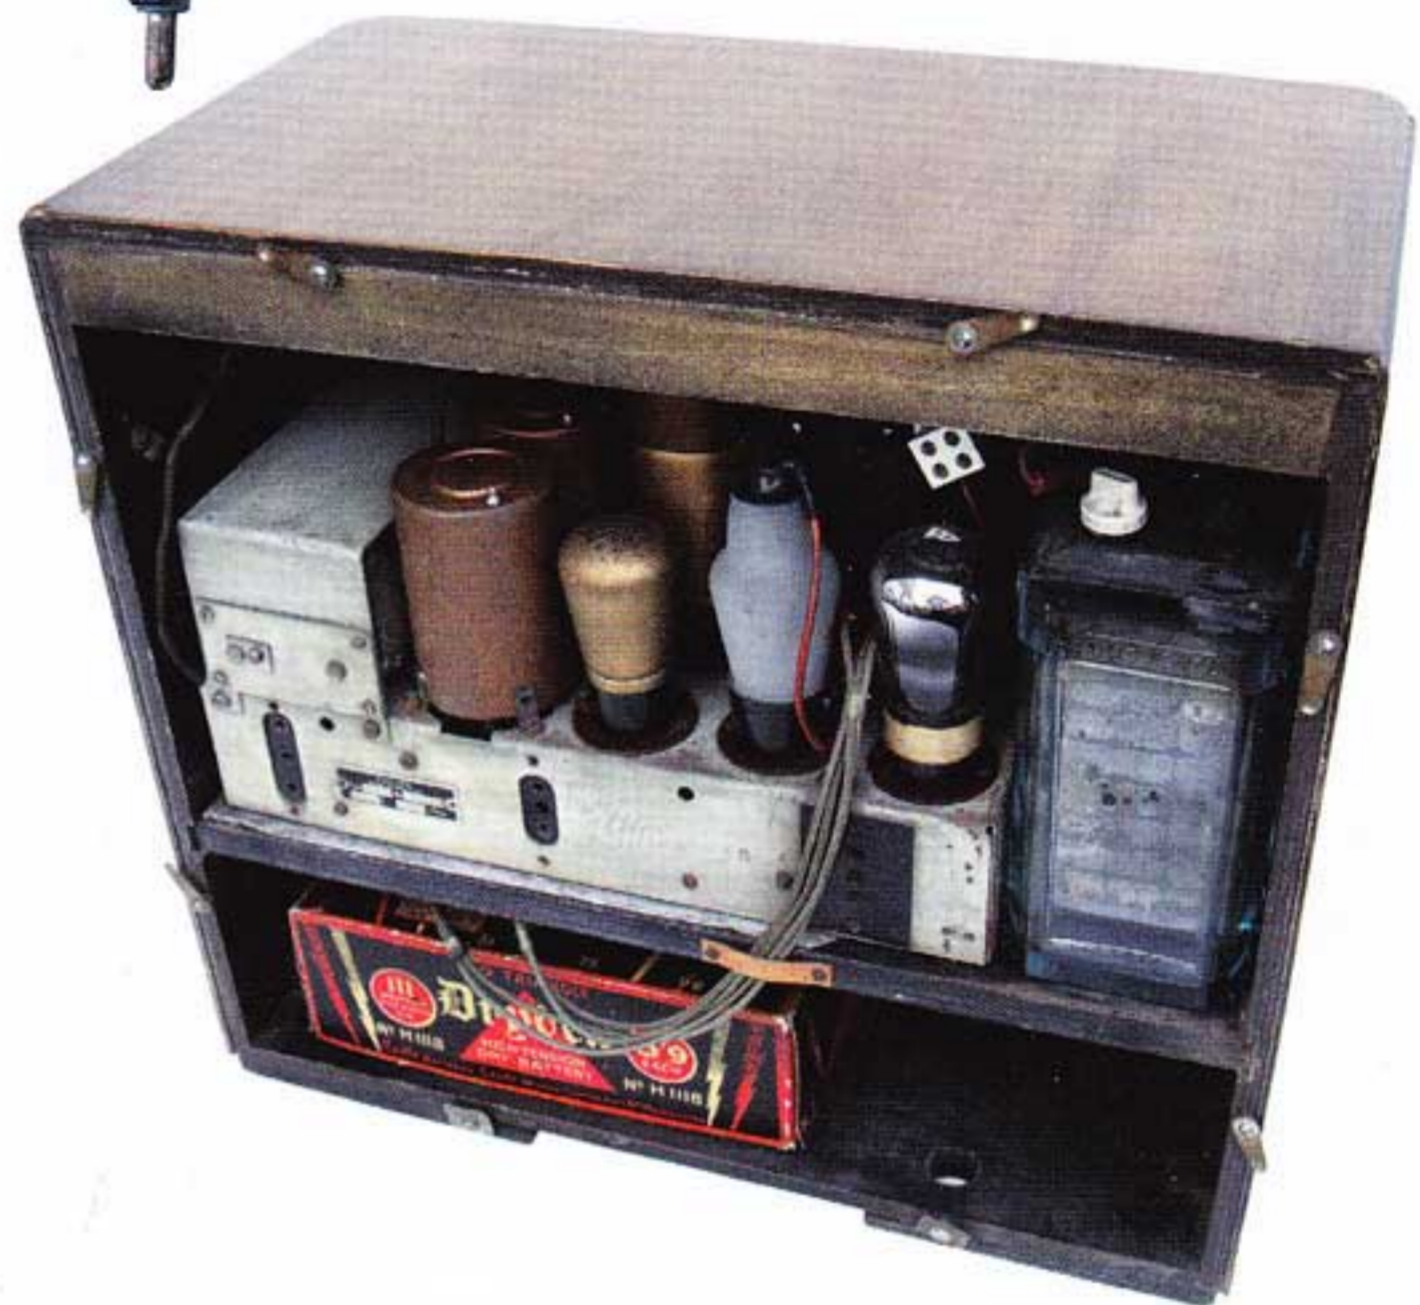
Back off, batteries installed

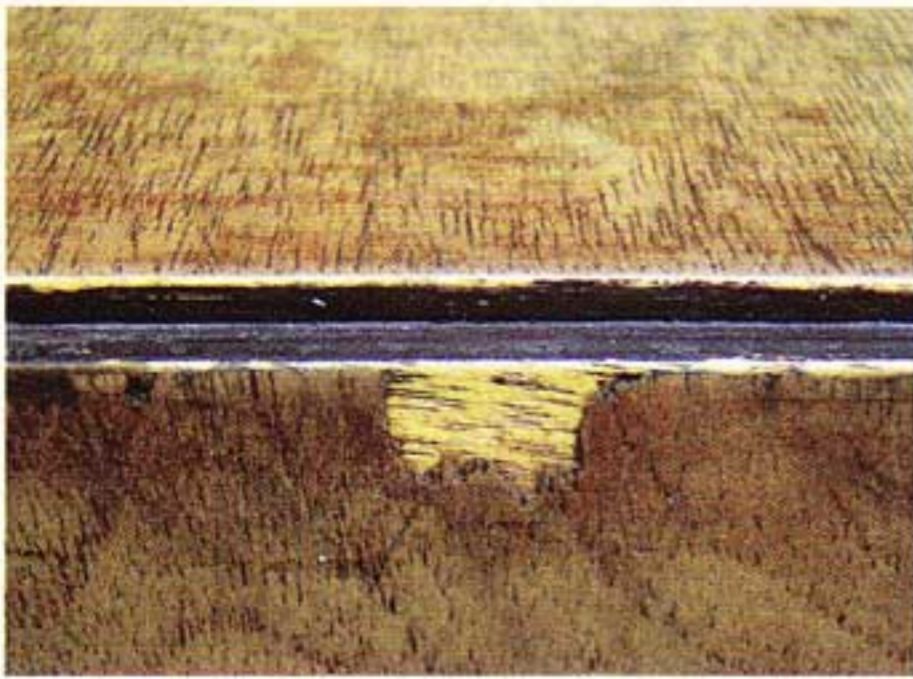
The cabinet was cleaned with foam cleaner and then wiped over with white spirit, I noticed that in one place the previous restorer had sanded through the veneer, there were several digs and small pieces of veneer missing, all of this can be disguised with filler and stain, but there's a large chunk right in the middle at the top which had to be dealt with as it's a real eyesore and difficult to hide. I cut a piece

The missing piece of veneer

of veneer of as close a colour and grain match as I could find, (salvaged from a wrecked set) slightly larger than the chunk missing, I then placed this over the gap and accurately cut the original veneer round it with a scalpel. I then trimmed the hole out to the cuts so the new piece would fit exactly, this was glued in place with PVA glue and held with masking tape while the glue dried. The new veneer was slightly thicker than the original so it can be cut back flush with 900 grade cutting paper (Halfords).

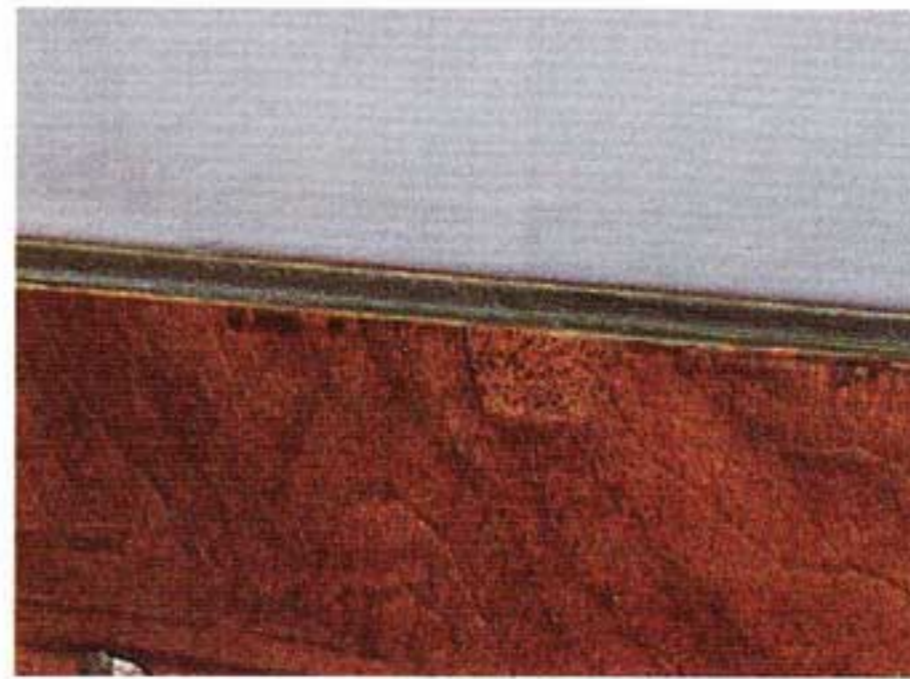
Veneer repaired

The rest of the digs and missing veneer were small and filled with wood filler of similar colour and then cut back with fine cutting paper ready for the new finish, the new piece of veneer and small areas where the previous sanding had gone through the veneer were colour matched with wood stain.

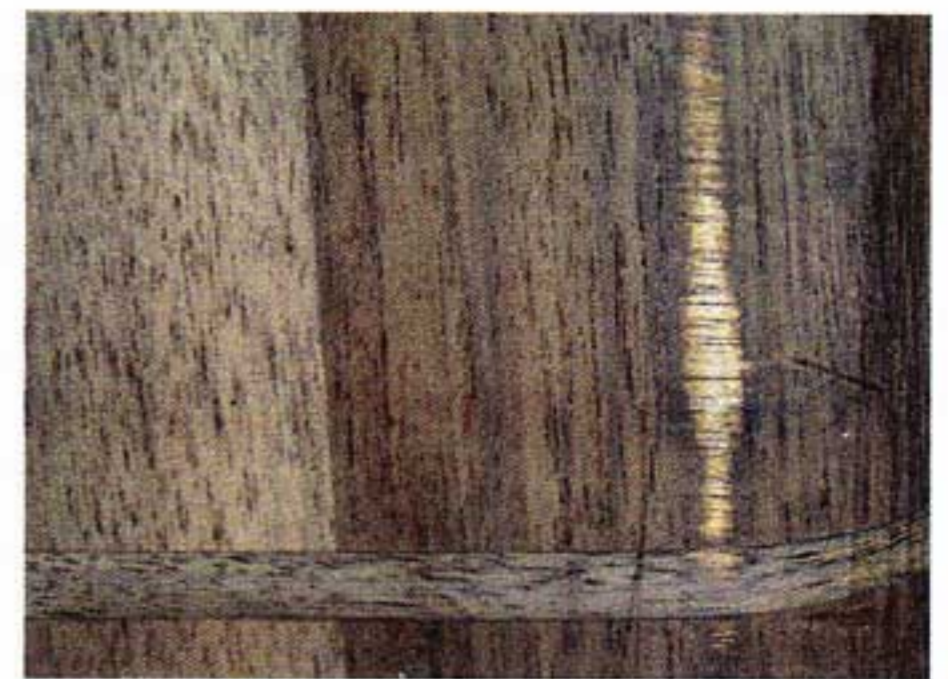
The veneer rubbing through

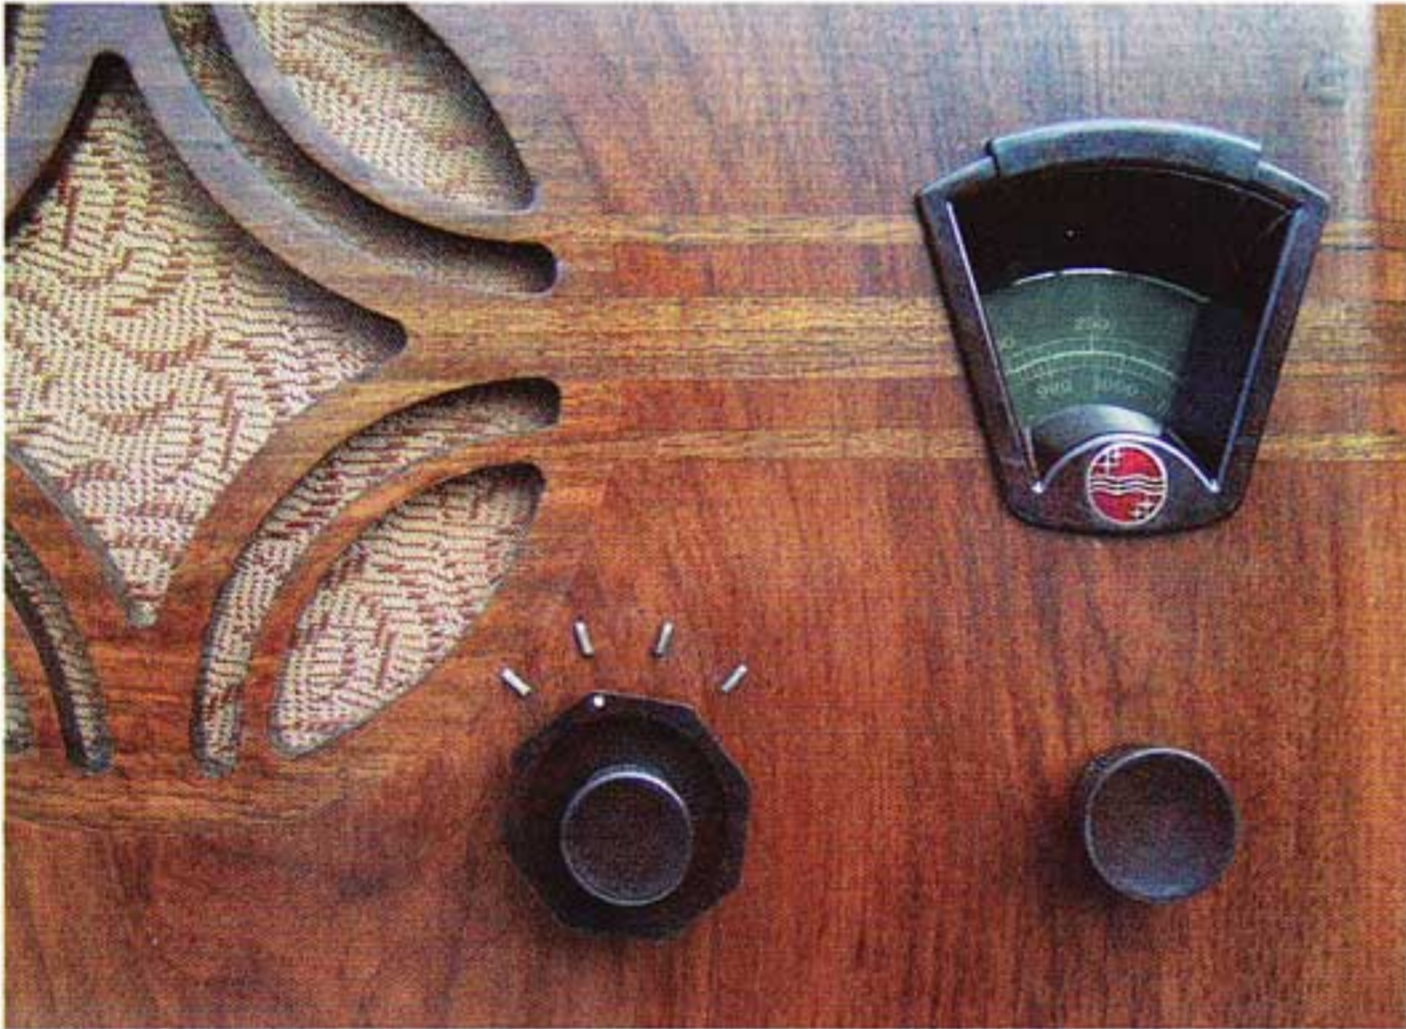
First released in 1934, this set seems to be only part Art Deco in style as it has a nice inlaid veneer of different woods around the speaker fret and across the front and around the sides of the cabinet, but an earlier conventional keyhole style tuning scale. Although this is nicely calibrated in metres, there's no room for station names, generally the set's still in keeping with a nice piece of furniture.

The inlaid veneer and tuning escutcheon

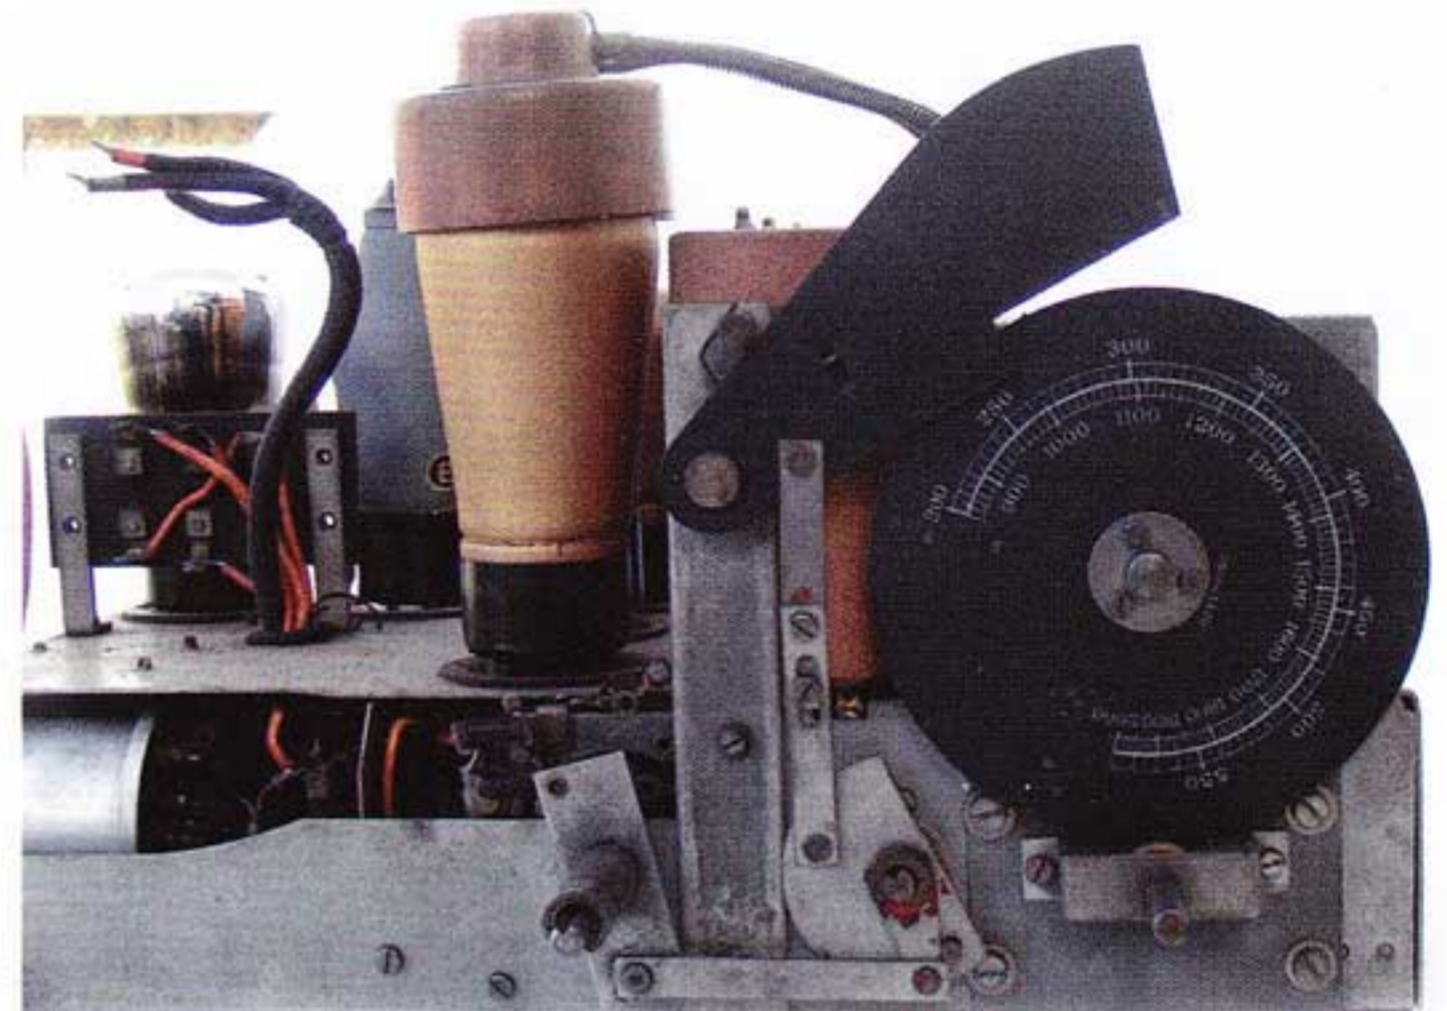
The tuning scale shutter mechanism

The tuning scale has a shutter blanking it out when the set is switched off so you will not run the expensive batteries flat, this employs some quite heavy mechanics for this relatively simple task with little chance to go wrong. The set also has a tone control, R18, or top-cut as I think they preferred to call it in those days.

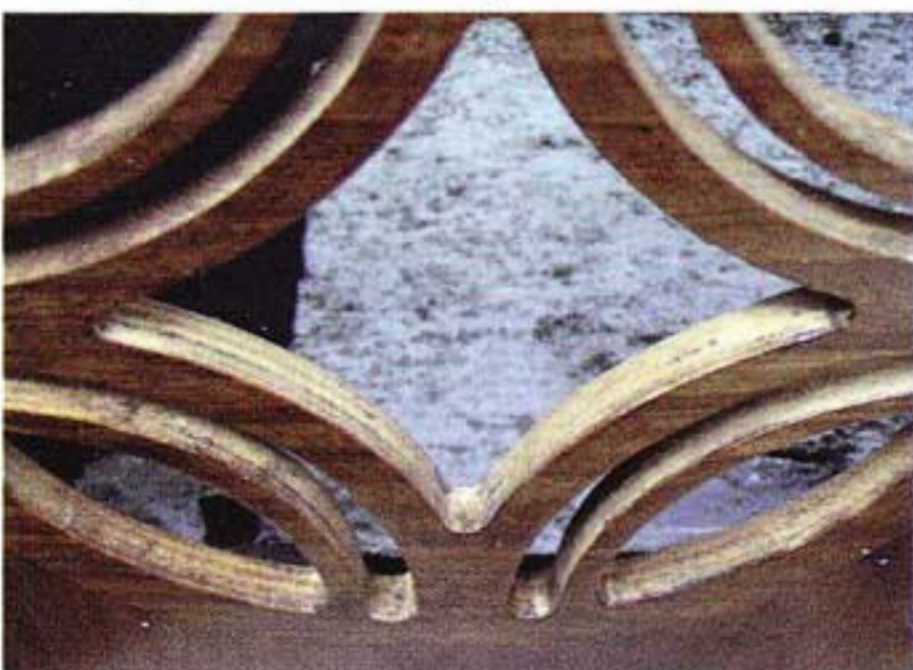
At this stage the flaking dark brown paint used on the non veneered ends of the plywood between the front and top of the set, were sanded smooth ready for a new coat of paint. The visible end of the plywood in the speaker fret was also painted brown, this required a little more attention as the layers of the ply were uneven, probably due to exposure to dampness sometime during

The fret end of the ply ready to paint

its long life. The really proud bits were cut back level with course sand paper, then all exposed end grain plywood sanded smooth and primed with diluted Unibond (PVA Glue 50/50 with water) ready for re-painting after refinishing the rest of the cabinet.

In the speaker fret two coats of matt undercoat were required to fully hide the plywood end grain and obtain uniform smoothness. On the ridge between the front and top the set the paint was over-lapped very slightly as the phantom sander had rolled off the edge of the veneer revealing a fine line of lighter plywood. The top coat of paint was a mix of colours, gloss and undercoat to get the colour and level of gloss right; modern paint usually needs toning down a bit as its always too glossy and colour rich. (Sometimes just a spot of matt black is all that's needed)

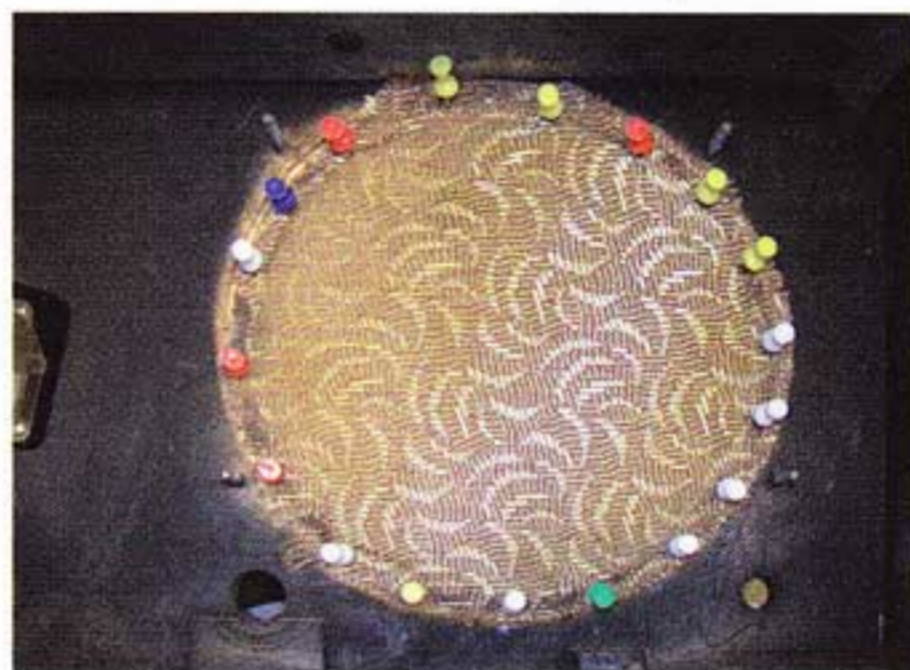
The speaker cloth glued and pinned

back into the cabinet. (I usually leave it in the garden shed until ready to refit, a damp place to undo the shrinkage when ironed and avoid sagging if ever stored in humid conditions). The speaker has a lip pushing the speaker cloth forward into a recess in the front panel but to avoid the cloth sagging I prefer a ring of glue around the outer edge to hold it in tension, drawing pins hold it in place while the glue dries. While the glue is drying I'll refit the wave change markers by tapping them back into their original holes with a small toffee hammer with some masking tape on its face to avoid damage to the new lacquer, with just a small touch of super glue to ensure they don't fall out in the future. The tuning escutcheon refitted and the cabinet is now complete.

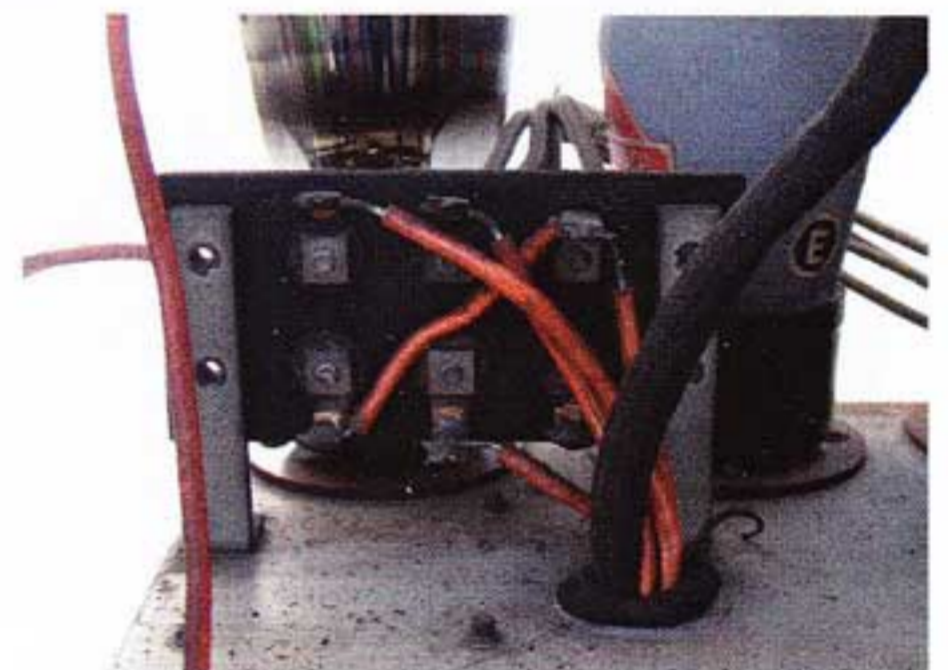
The rear of the battery wire terminal panel

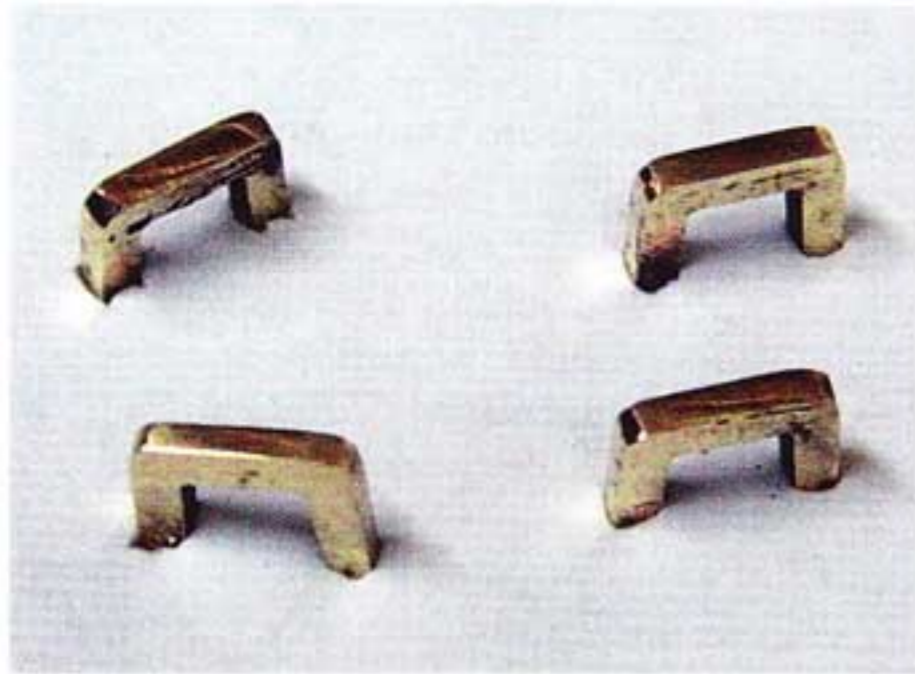
A spray of lacquer for the wavechange markers

The knobs were cleaned and polished at the same time and the indent in the wave change switch re-filled with a touch of gold coloured paint. This indent points to one of four brass markers on the front of the set, Off, MW, LW, Gram, these will have to be removed before the re-finish of the cabinet, they stand quite proud of the woodwork and a tug with a pair of pliers pulled them free quite easily. These were also polished with Brasso, then pushed into a piece of card to keep them vertical while being splayed with Lacquer ready to refit.

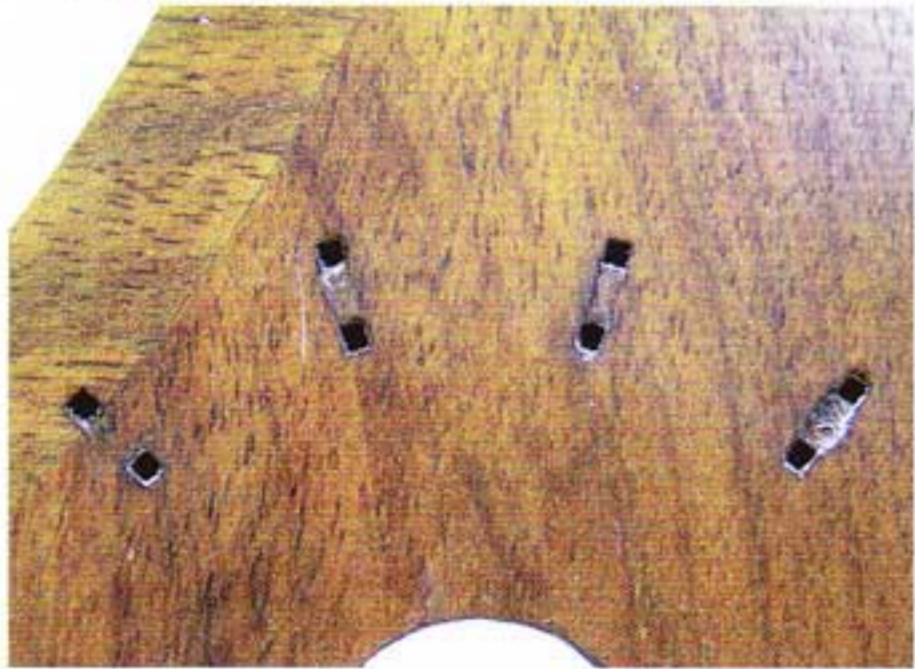
Wavechange marker holes

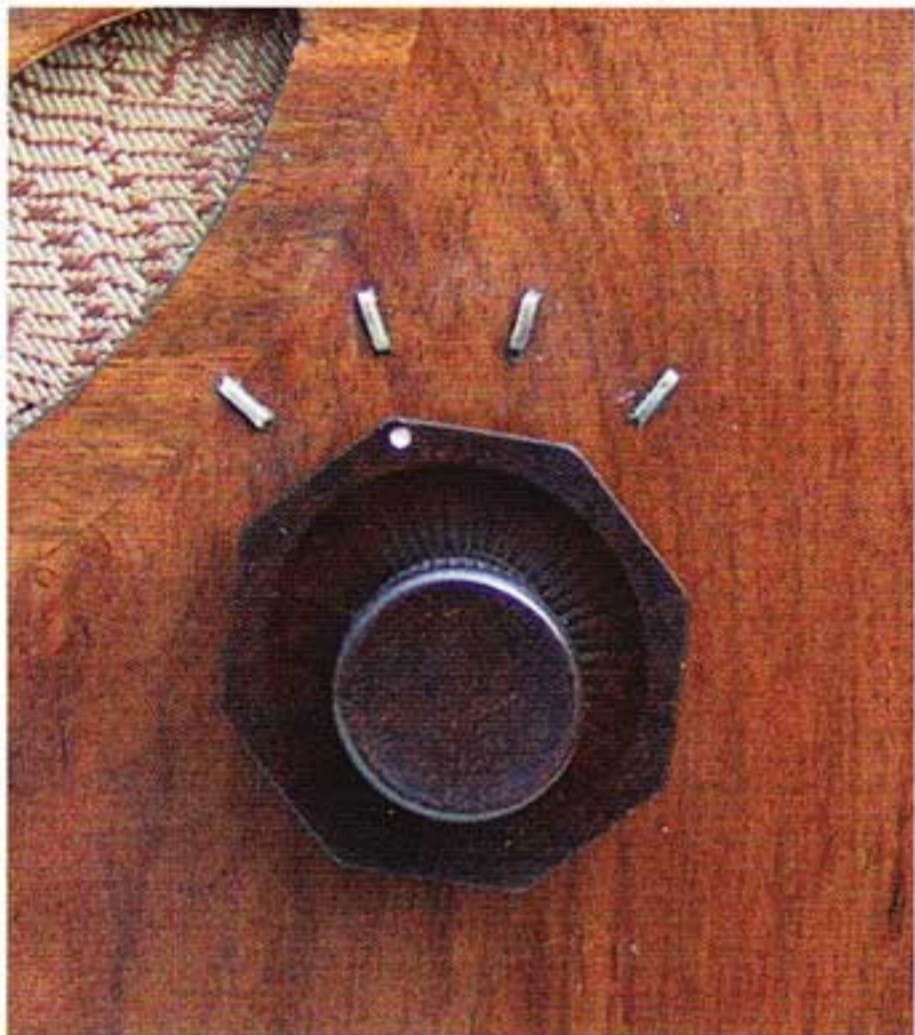
The wavechange markers in situ
