# The Philips 372B *Super Inductance* By R.J.Grant

A battery set as suggested by the 'B' in the model number, from the Philips "Super inductance" range. I purchased this set from a boot fair, when the back was removed it was found to still have both of its batteries, a Drydex combination HT with grid Bias battery, and a glass accumulator. Unfortunately on discovering the batteries inside I failed to hide my enthusiasm, this didn't leave much manoeuvring room when it came to reducing the price. The battery is a real bonus as the batteries in these sets are often missing and an original to restore or as a pattern to reproduce for another set which really makes it a double-find.

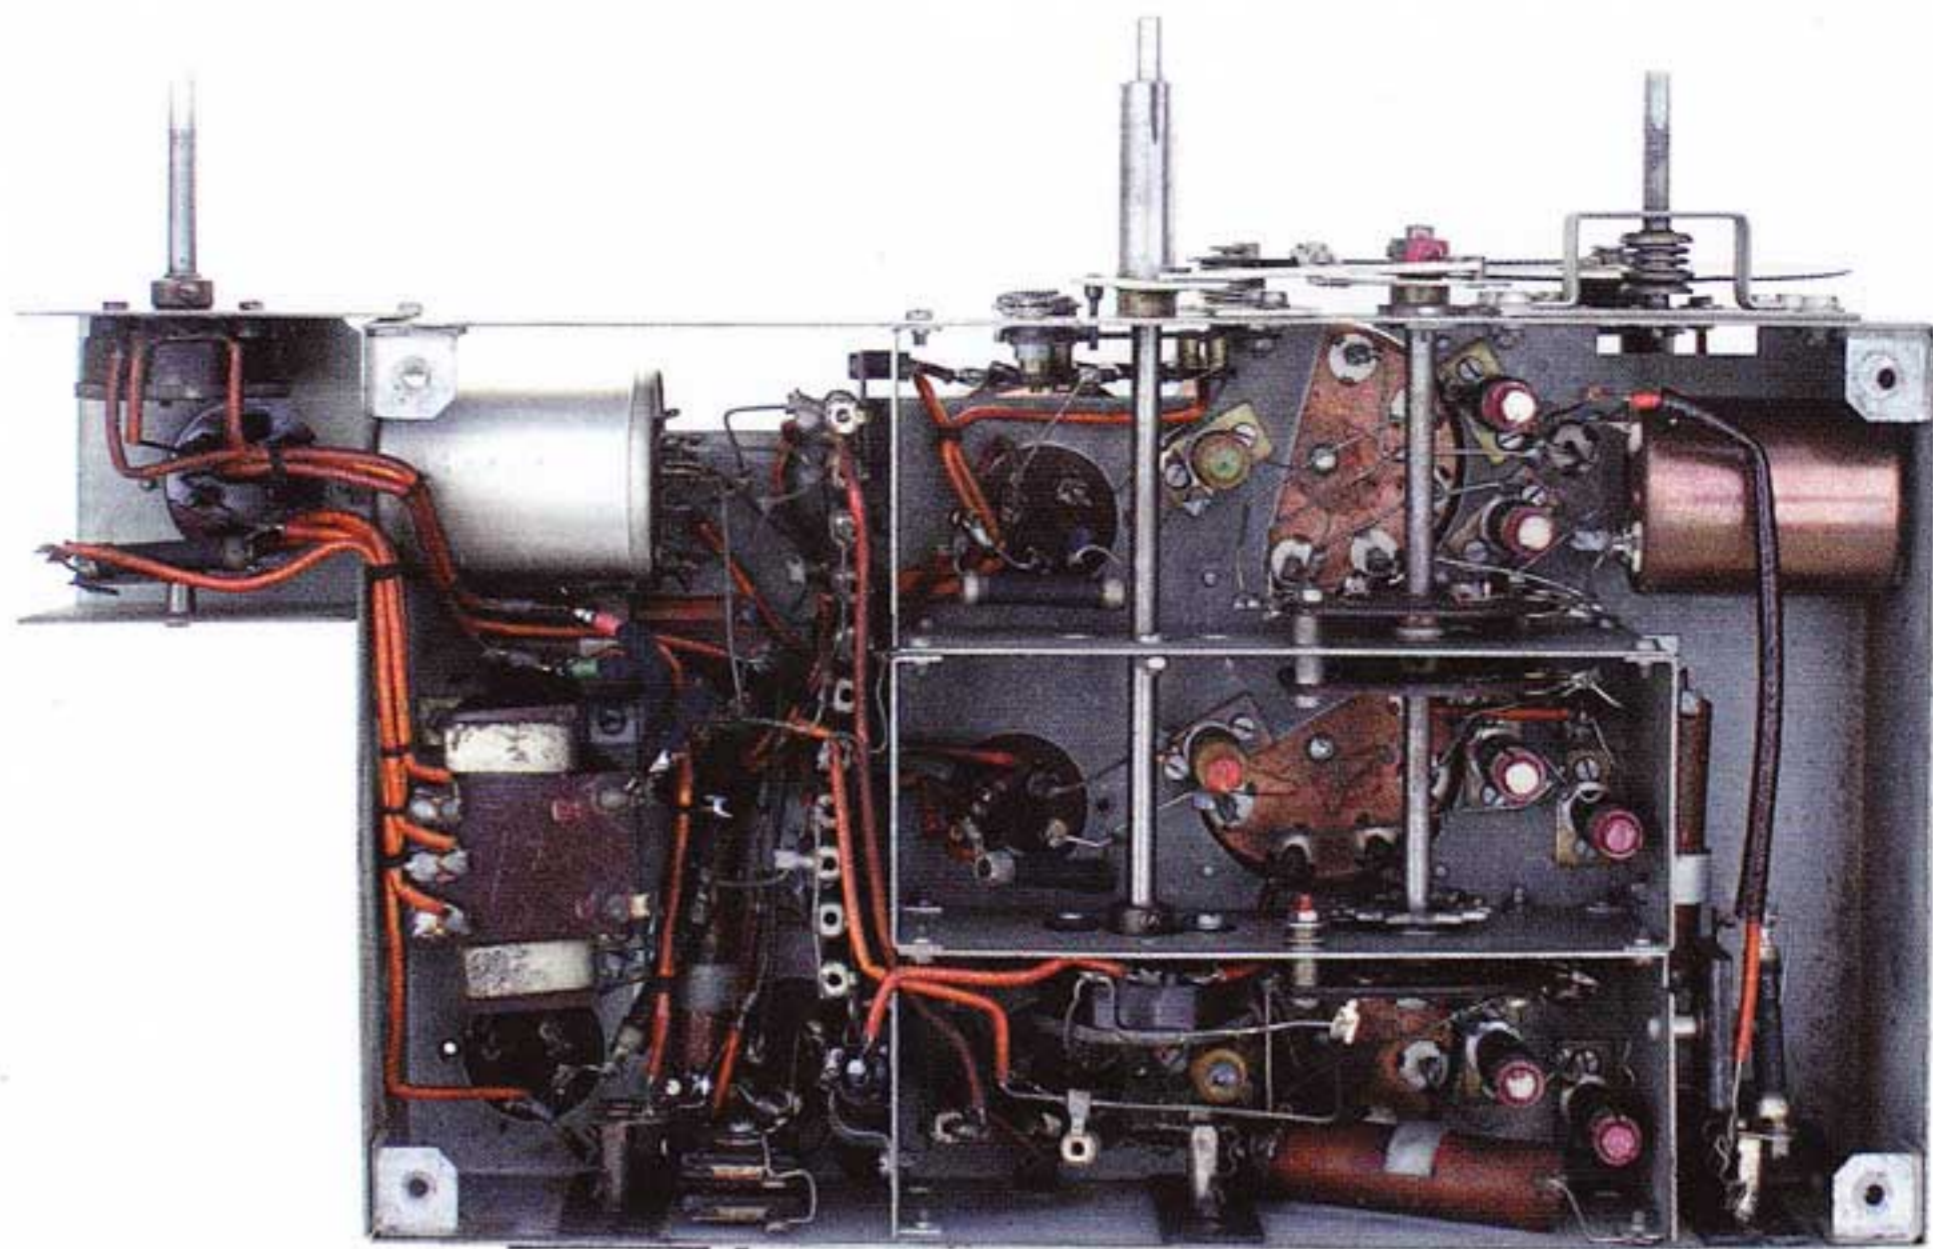
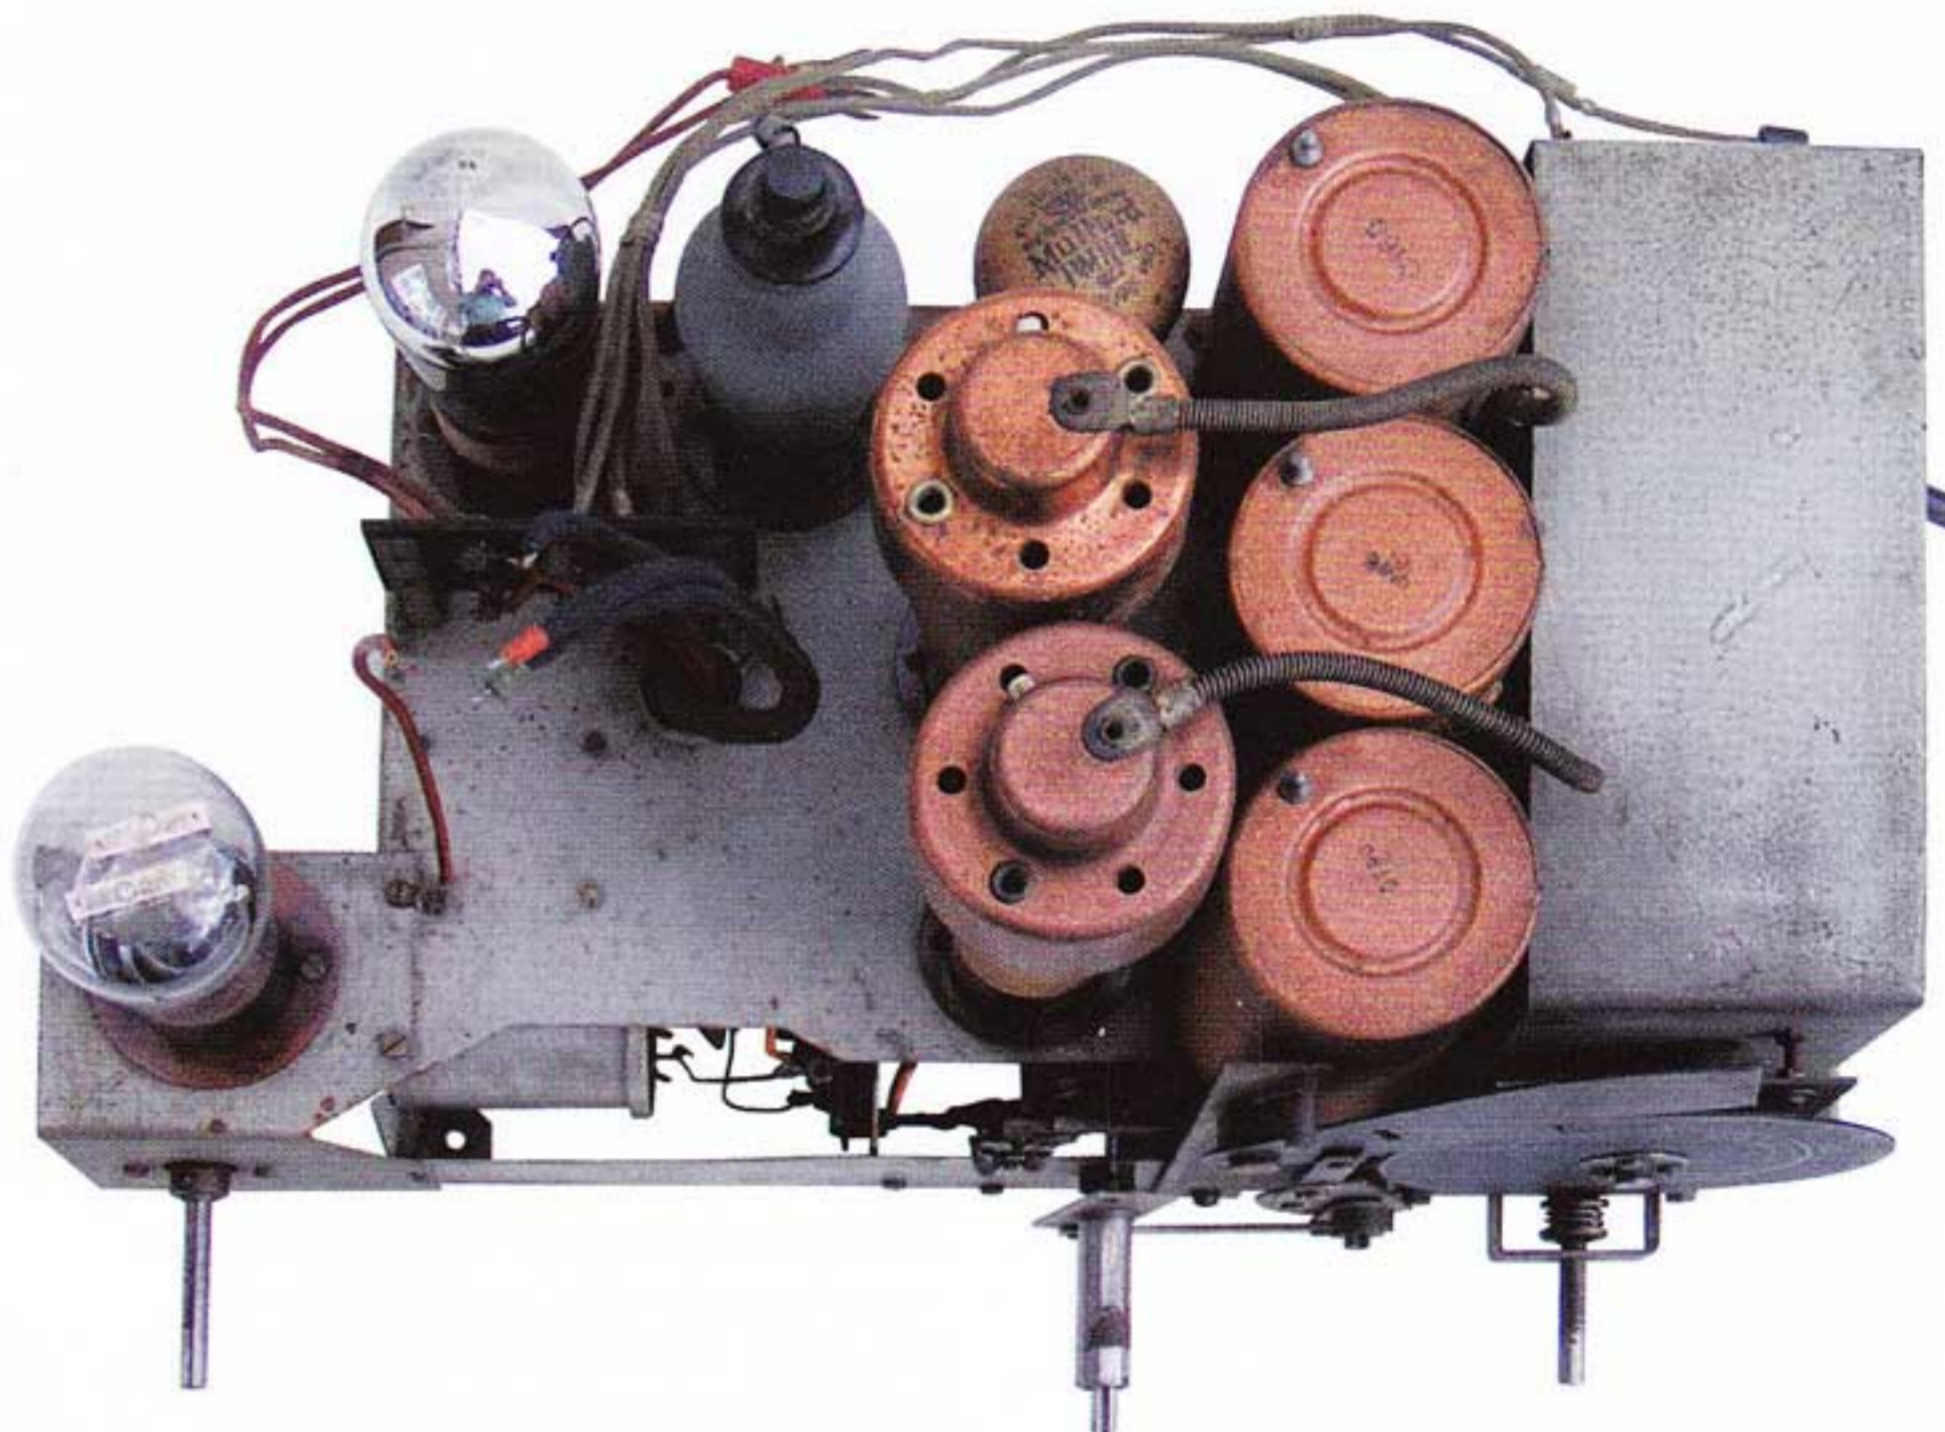
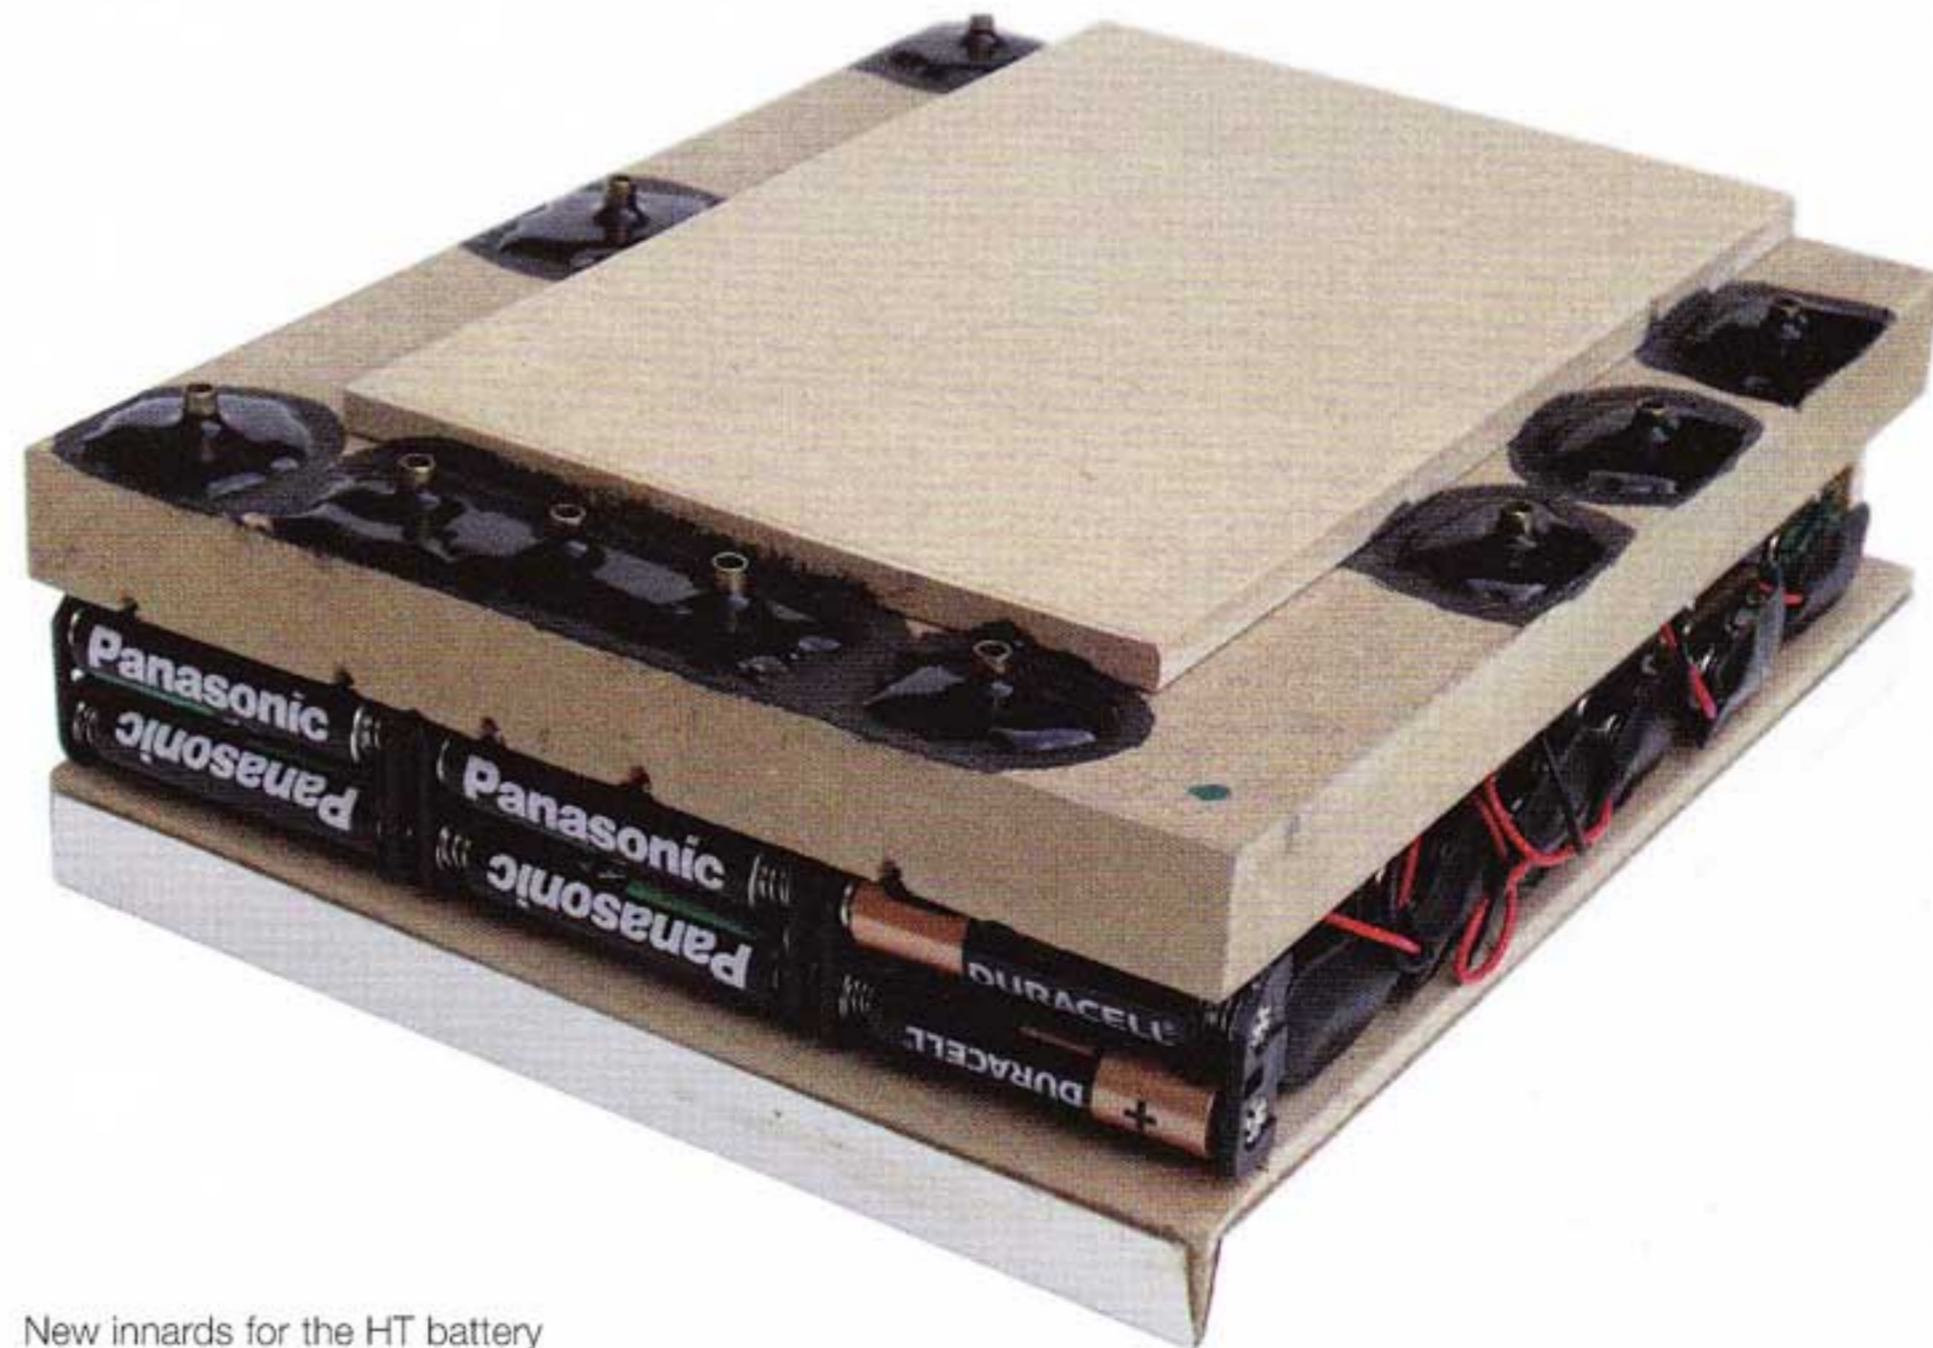
New innards for the HT battery

The new battery was made from two pieces of 15mm MDF, cut to size and glued to a third smaller middle piece of wood, so the thirteen PP3 and six AAA batteries can be installed in the gap around the edge.

The middle spacer piece was cut to size so that the whole height of the battery is 5mm less than the inside of the cover, as the protruding terminals are inside of the cover. The terminal sockets were made from 0.5mm brass shim stock, about 20mm wide strip and wrapped round a 4mm drill to form a tube.

The top of the battery was marked out and drilled with 4mm holes for the terminal sockets, the brass tubes pressed onto these holes with about 4mm protruding through the top, leaving 1mm underneath to solder on the connecting wires, then fixed in place with touch of super glue. To finish off a small puddle of "Araldite" 2-3mm deep placed round the terminals and when set painted black to resemble the pitch used in the original battery. Finally a 5mm piece of MDF or corrugated card was cut to fit inside the terminal area stopping the cover from sagging onto the top of the battery. The battery was wired using PP3 connectors and AAA battery holders from Maplins. The battery now complete just needs the outer cover from the original to finish it off. I intend to make a reproduction battery cover for everyday use preserving the original but for now the original will do.

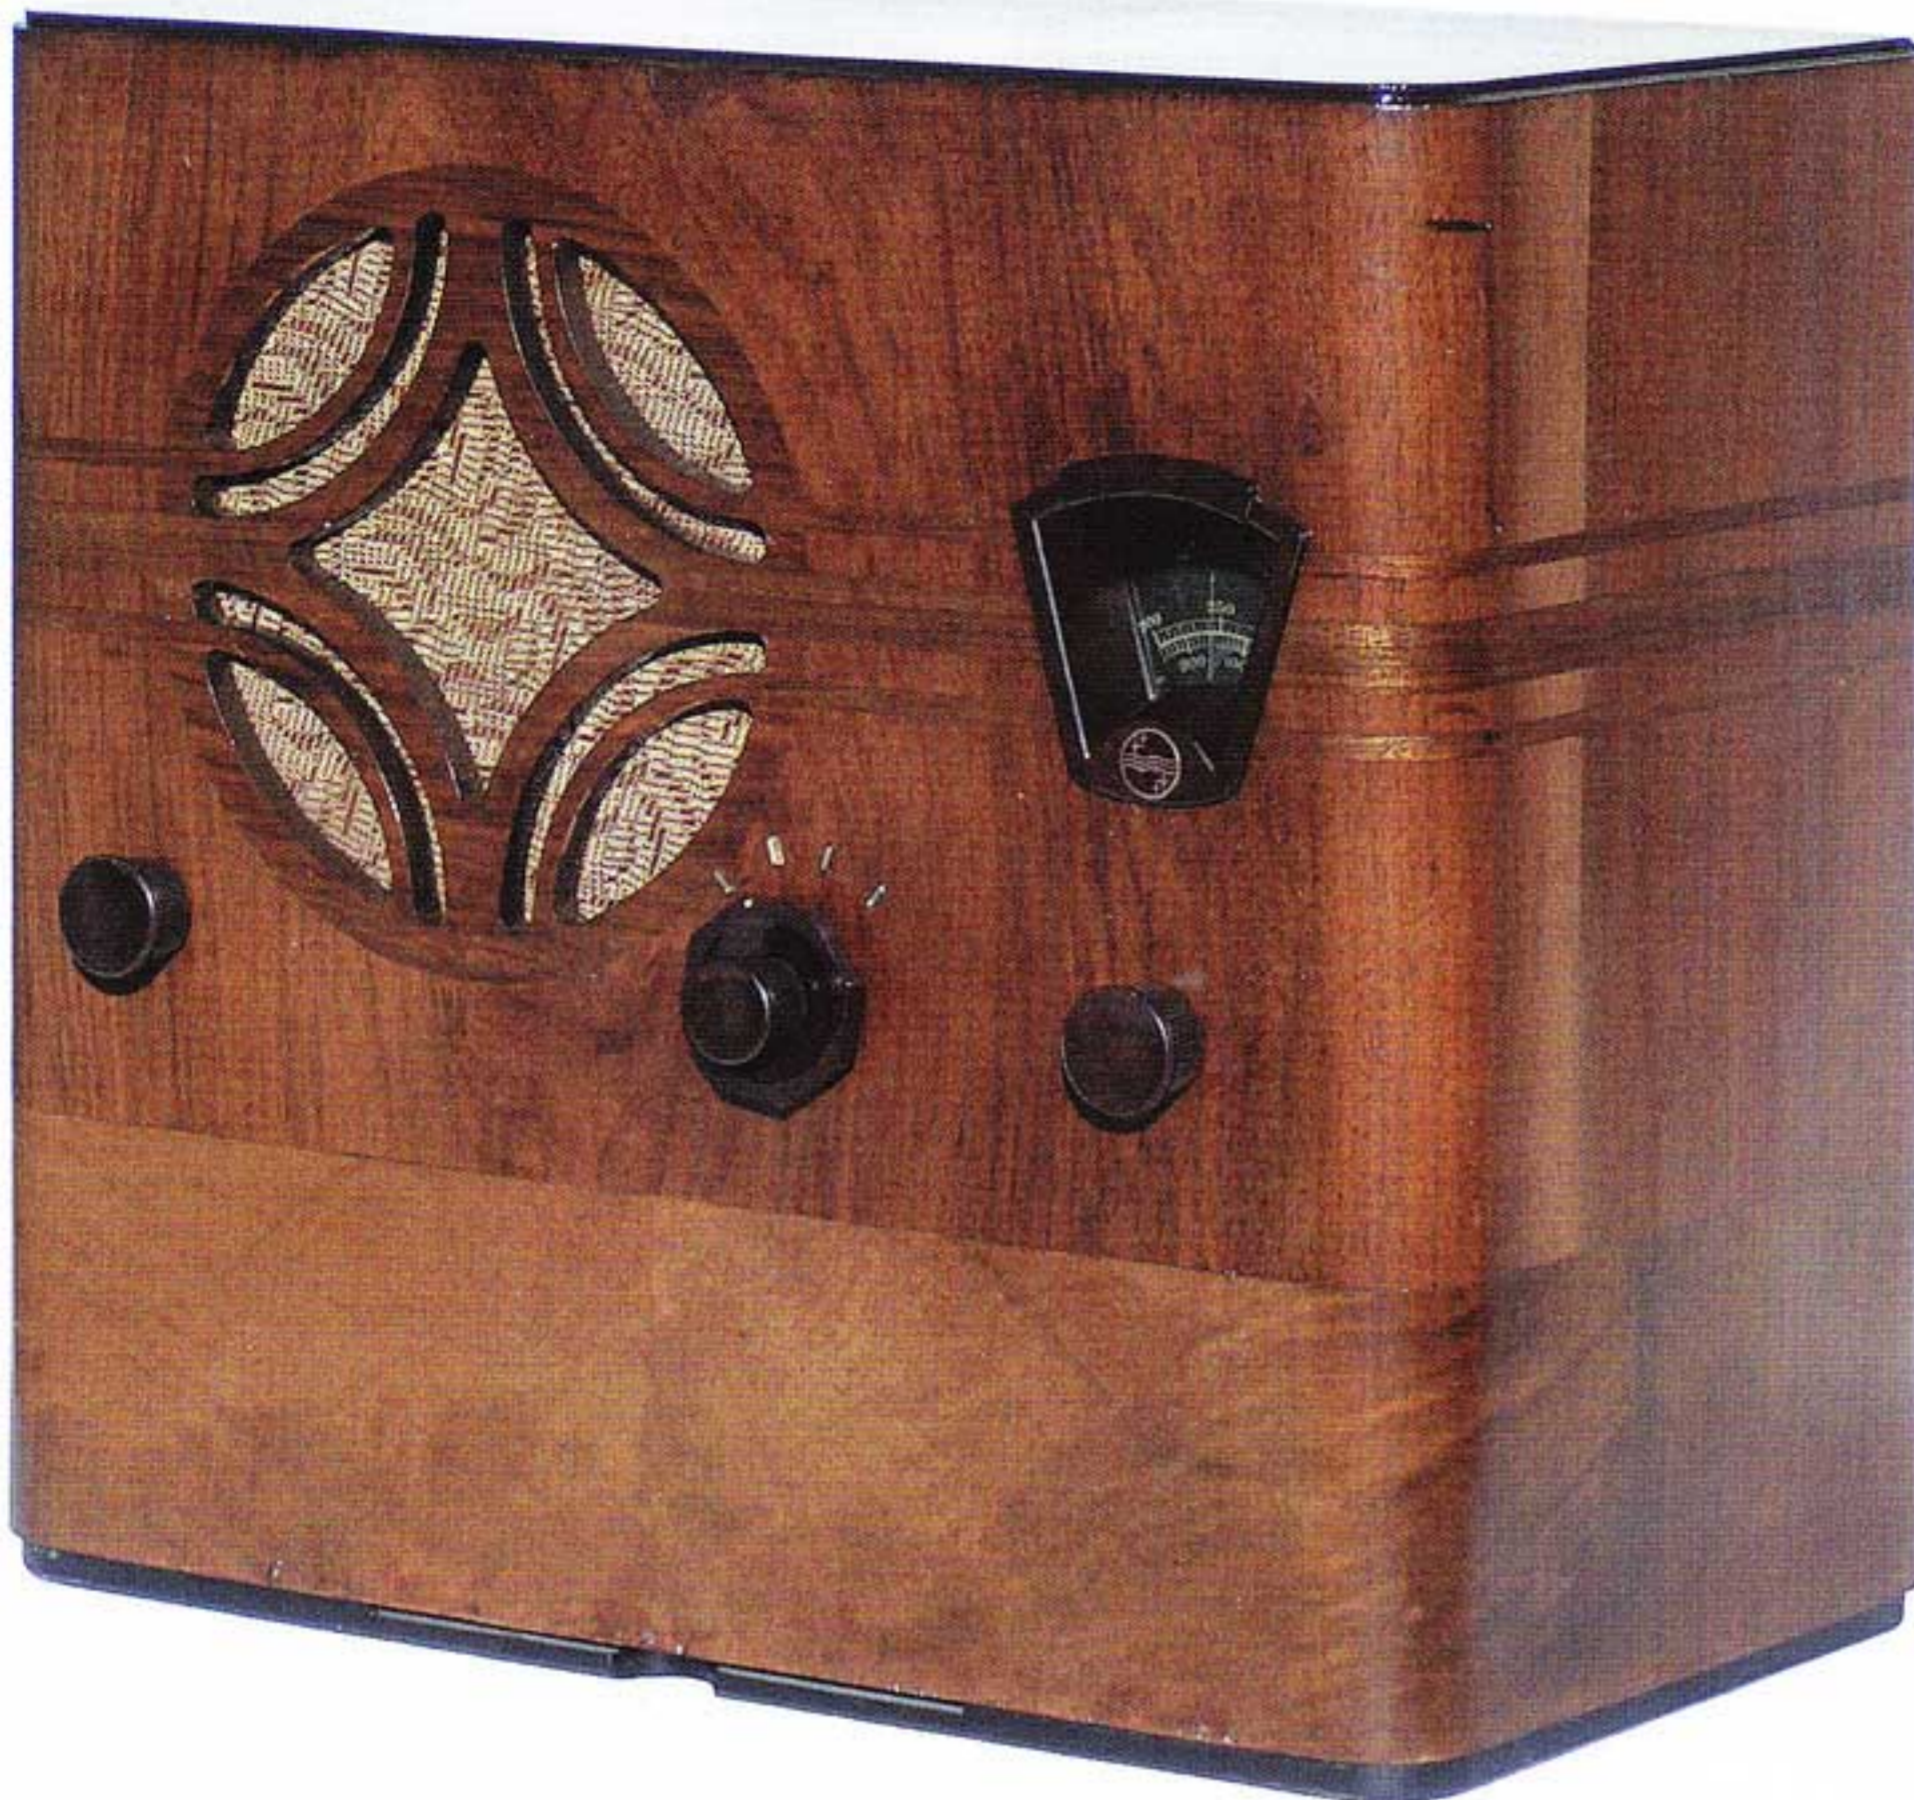
The finished set
