The Philips 660A by Peter Nash

Direct Action Tuning

by Geoffrey Dixon-Nuttall (originally from the Summer 1997 issue of The Bulletin)

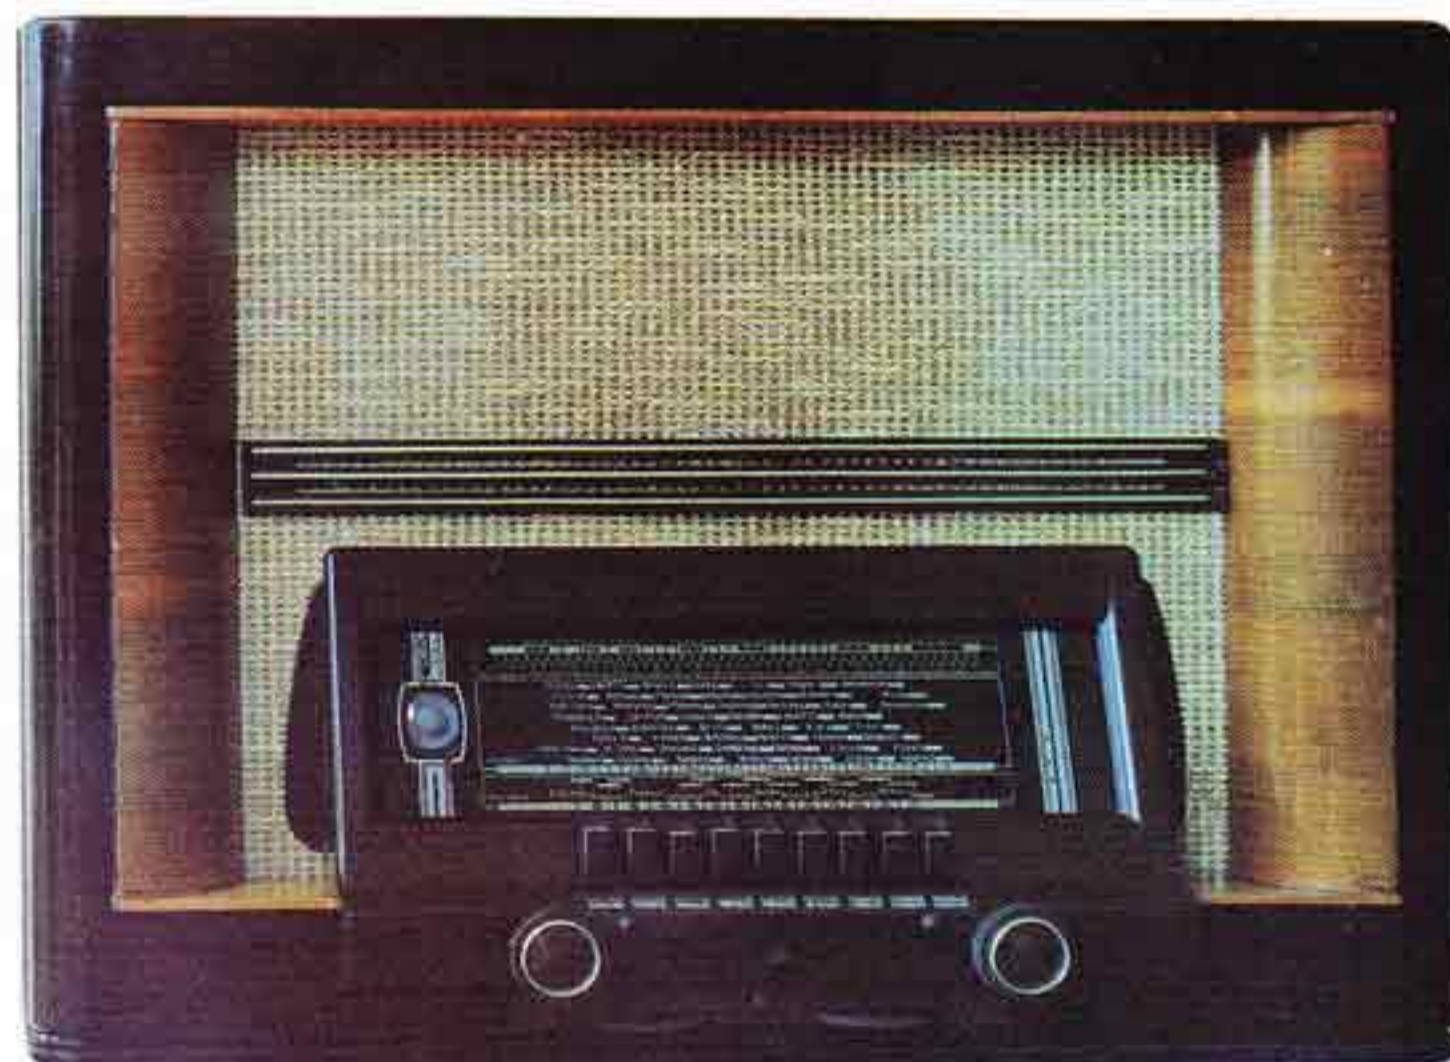
Philips 555A

Philips obviously took all these objections to heart, and the next range of sets, which came out for the 1939 Show, was much more civilised. What they did was to change the press buttons to piano type keys. These turned a shaft which moved the pointer by means of a crafty arrangement of bell cranks, so that it would work at sufficient speed. This shaft also carried a crank, which pushed the

tuning capacitor into position. It was also arranged that this shaft could move the bandswitch if desired. Further, the tuning capacitor foils were tapered, so that the dial drive could be linear.
