# Restoring an Osram 'Four' New Music Magnet

by Gwyn Griffiths

# MURPHY TELEVISION

The blank screens of 1939 by Mike Barker

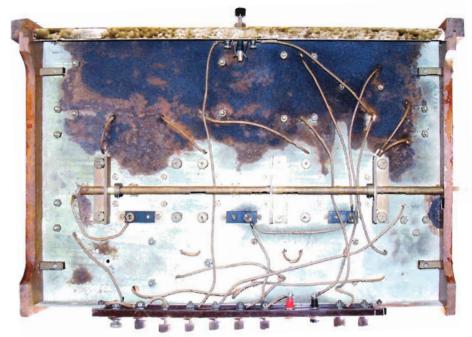
The front half of the underside of the chassis was corroded, and would need attention, but I wanted to see if it was working before dismantling the set entirely, which was my intention. In this regard, working with what was originally a kit had several advantages. As the receiver was meant to be assembled with few tools, disassembly would be very easy; almost all connections were by screw terminals.

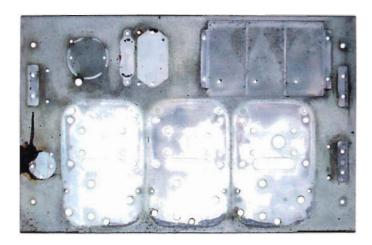
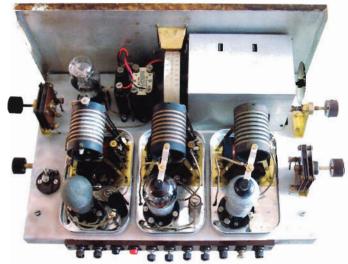
A close look had shown that the wave-change mechanism was actuated with three ball bearings, one for each of the two

RF stages, and one at the detector. Care was taken not to let them escape! Each of the three coil assemblies was then dismantled. This gave access to the three sets of switch contact pairs for the wave-change mechanism. Crocus paper and a switch cleaner restored the contacts to reliable operation.
